HISTORIC RESOURCES INVENTORY - BUILDING AND STRUCTURES

Building Name (Common) West Battalion Headquarters, New Haven Fire Department, Engine Co. 9
 Building Name (Historic) West Battalion Headquarters, New Haven Fire Department, Engine Co. 9
 Street Address or Location 120 Ellsworth Avenue
 Town/City New Haven Village _____ County New Haven
 Owner(s) City of New Haven Public Private

120 Ellsworth Avenue, New Haven, CT

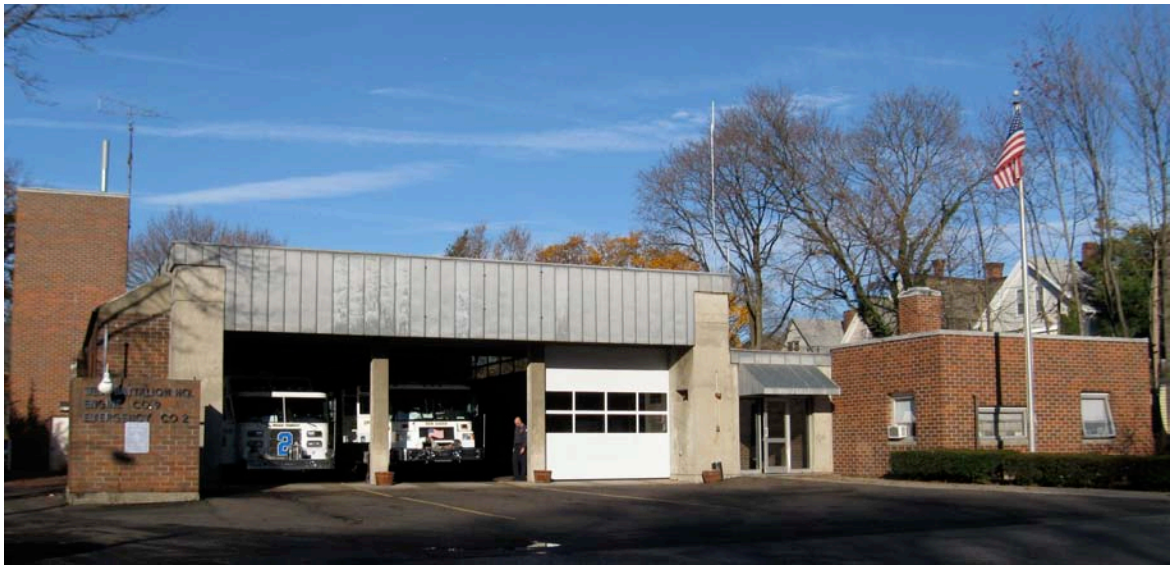
1. East elevation from Ellsworth Avenue, camera facing west.

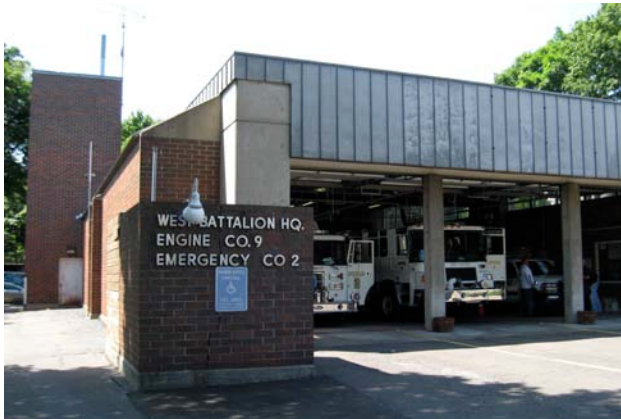
2. Southeast view, camera facing west, hose tower at rear beyond signage wall.

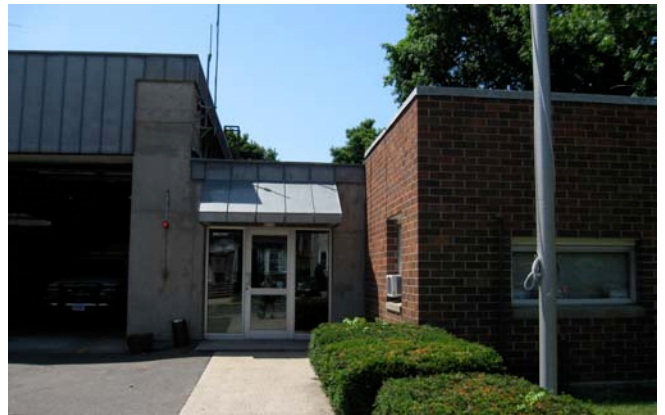
The building has a pedestrian entrance in a glazed link between the residential wing and the equipment garage; a simple shed-roofed porch of terne metal shelters the doorway. A similar roof covers the rear door to the residential wing. A brick wall stands forward of the building to carry applied signage lettering in a sans serif font; this is typical of the firehouses designed by the Carlin firm. At the north side a small area of landscaping connects the low wing to the scale of the neighborhood.

3. East detail of pedestrian entry, camera facing west.

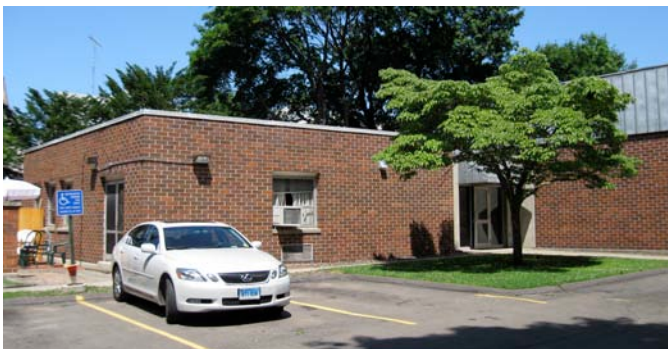
4. Southwest view of rear of building, camera facing north.

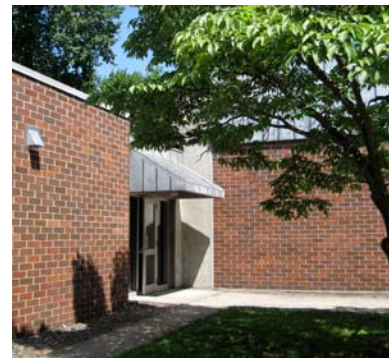
5. Rear entry porch roof detail.

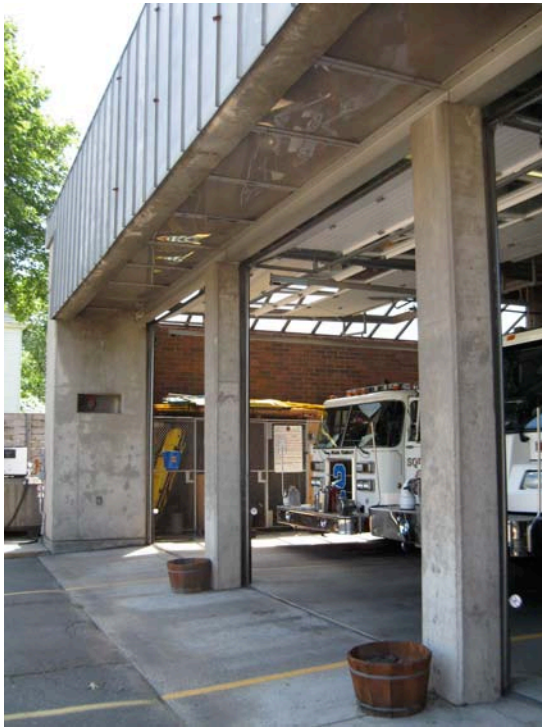
6. East front doors, view of skylights, camera facing south.

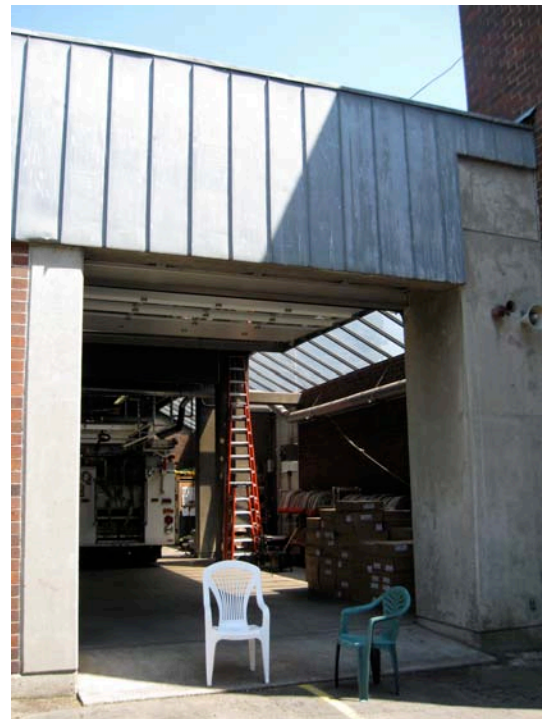
7. West rear door, view of skylights, camera facing southeast.

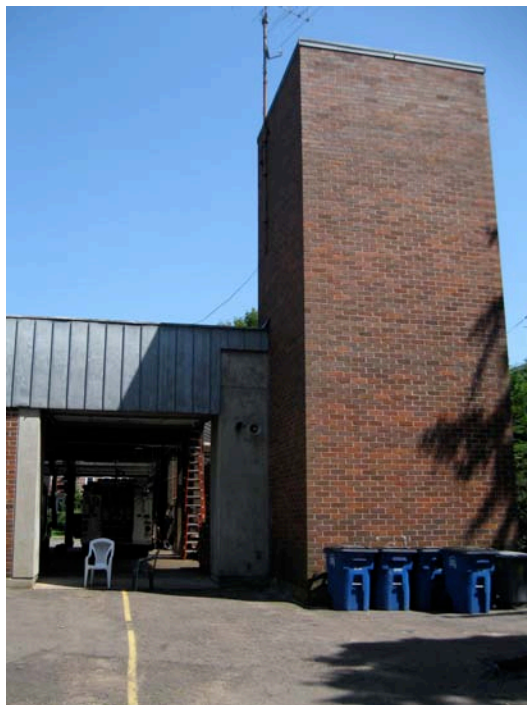
8. West rear view of hose tower, camera facing east.

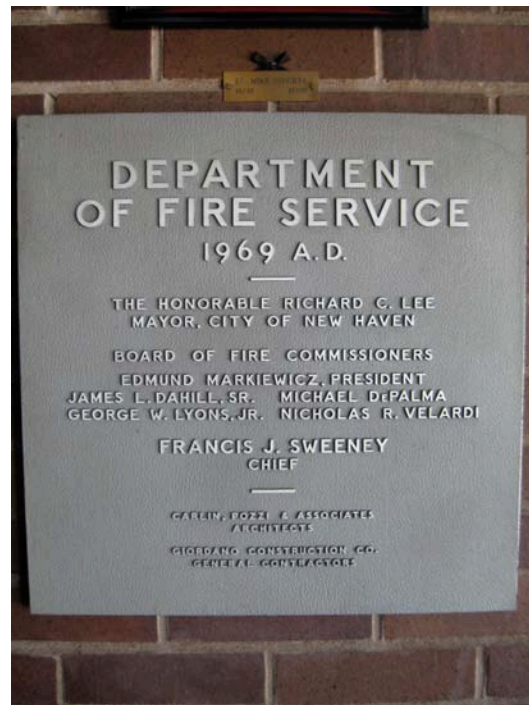
9. Dedication plaque inside lobby.

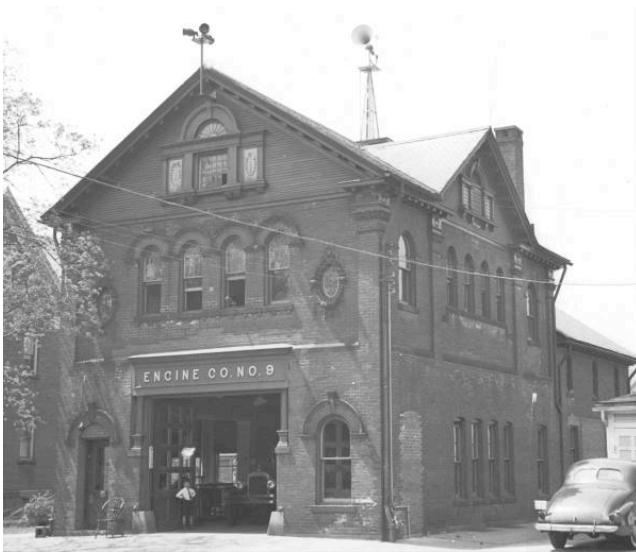
An earlier firehouse stood on the north half of the site; an adjacent lot to the south was purchased and structures demolished to provide more lot area for the new station, which is set back from the street behind a paved apron.

10. Earlier firehouse (demolished) at 120 Ellsworth Avenue

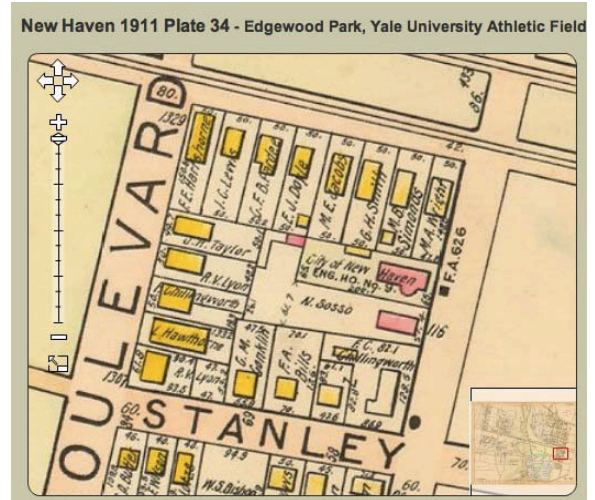
11. Atlas of 1911, map showing 116 Ellsworth Avenue, which was combined with Number 120.

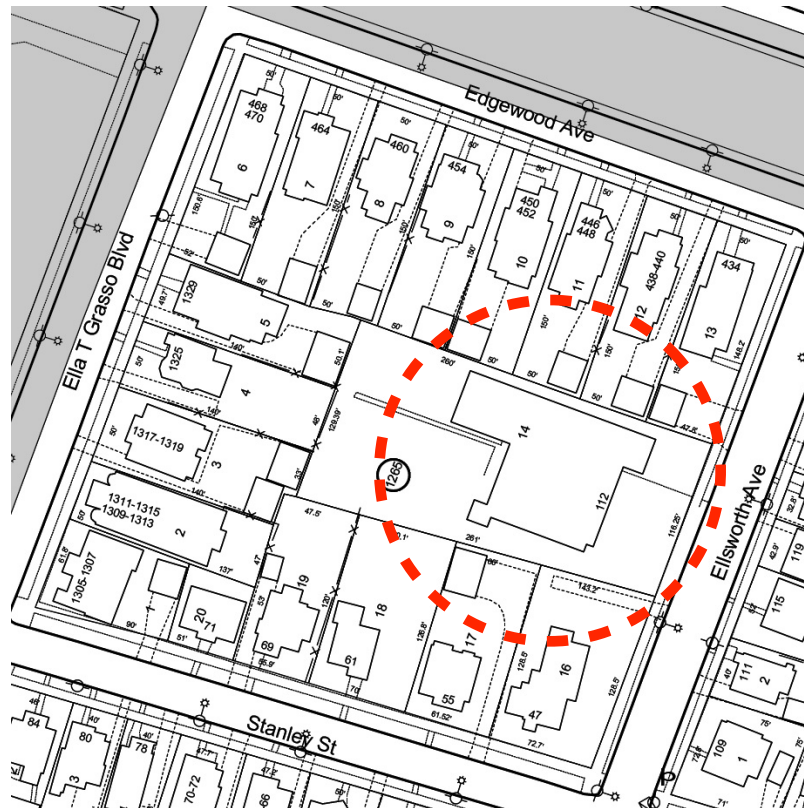
12. Site Plan – from City of New Haven Tax Map/Block/Parcel: 336/ 1265/ 01400, not to scale, North ↑

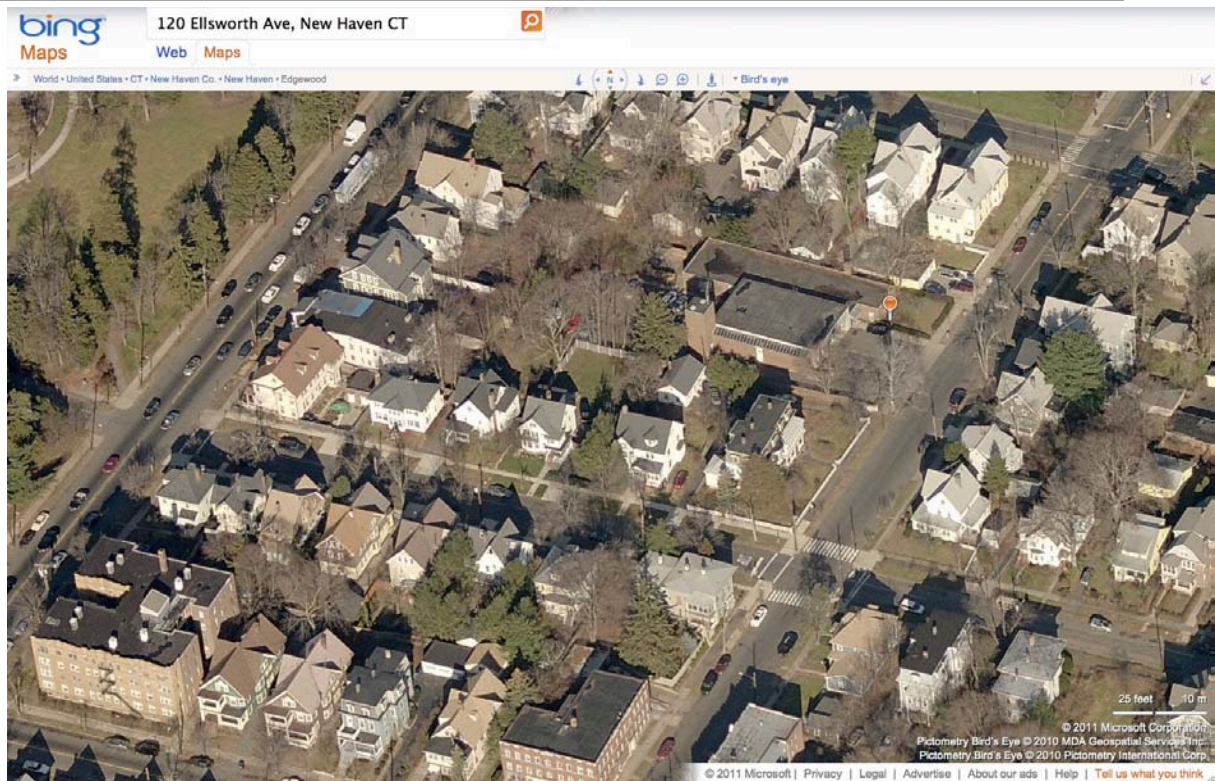
13. South aerial view from Bing Maps <http://www.bing.com/maps> accessed 6/01/2011.
