## HISTORIC RESOURCES INVENTORY - BUILDING AND STRUCTURES

Building Name (Common) Joseph Cohn & Son, Inc.

Building Name (Historic) Hi-Temp Corporation Repair Shop

Street Address or Location 80 Hamilton Street

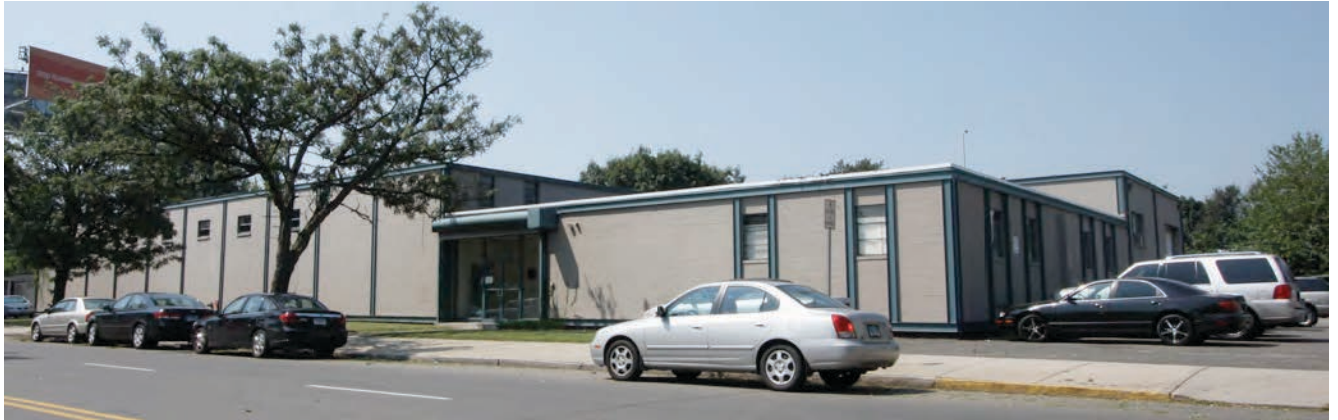
1. Northeast view from Hamilton Street, camera facing southwest.

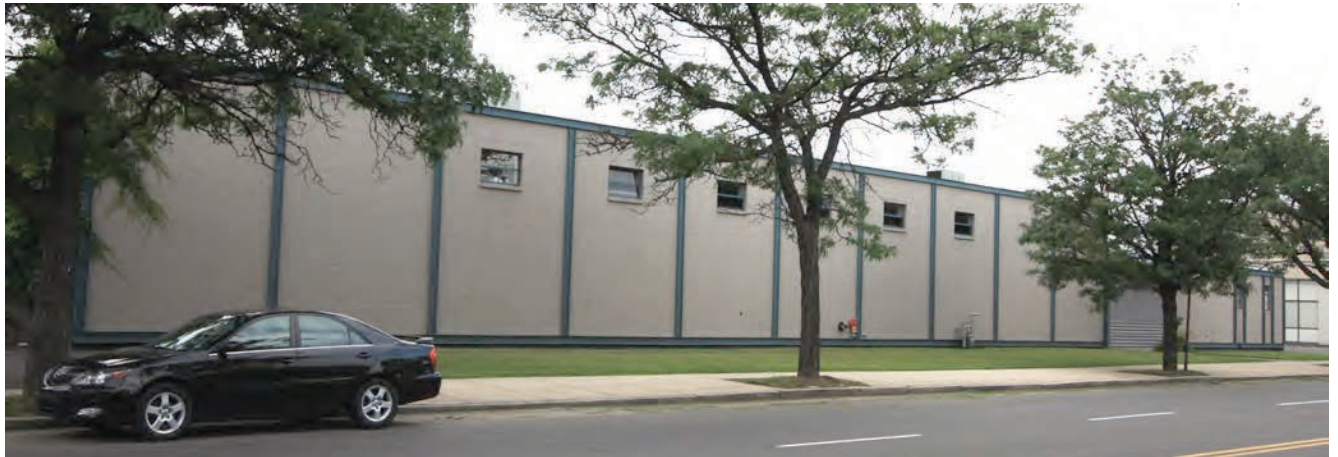
2. Southeast view of the tall block from Hamilton Street, camera facing northwest.

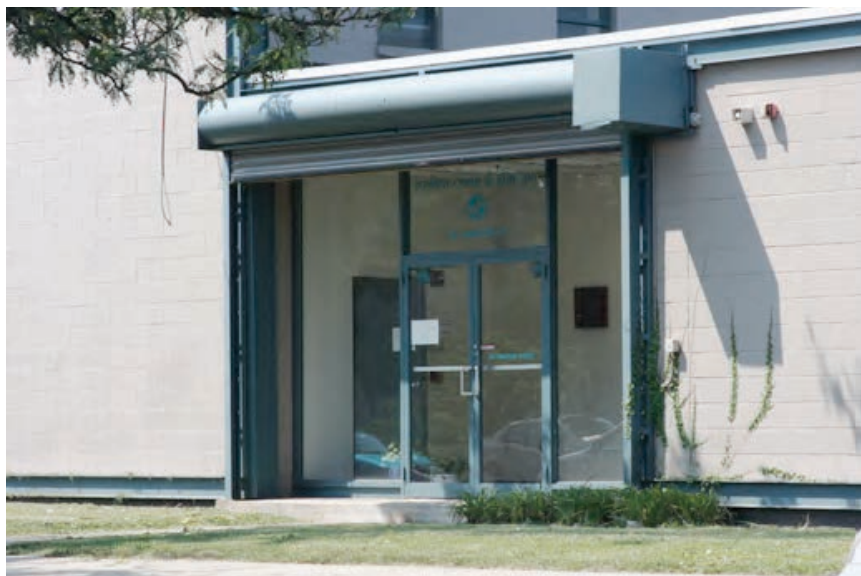
Alterations?  Yes  No If yes, explain: Security shutter over entry, weathering steel painted.

3. East view of entry doorway, camera facing west.
