HISTORIC RESOURCES INVENTORY - BUILDING AND STRUCTURES

Building Name (Common) Sage American Bar & Grill
 Building Name (Historic) Chart House Restaurant
 Street Address or Location 100 South Water Street
 Town/City New Haven Village City Point County New Haven
 Owner(s) D & A Restaurant Enterprises LLC Public Private

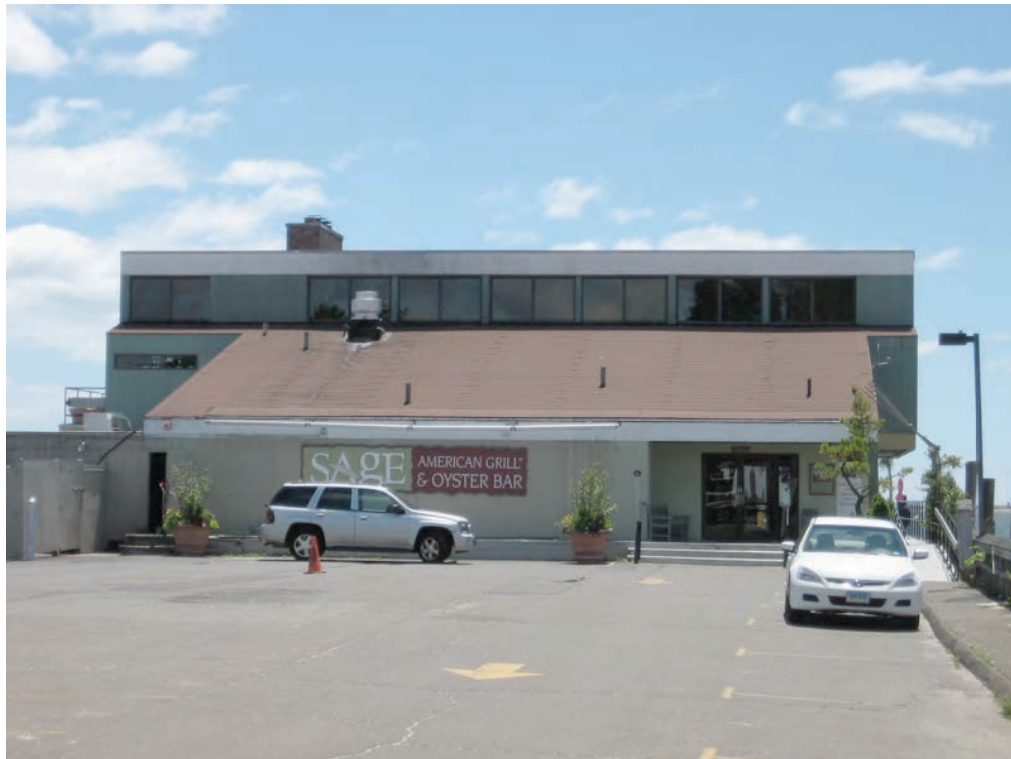
1. North (front) elevation from South Water Street, camera facing south.

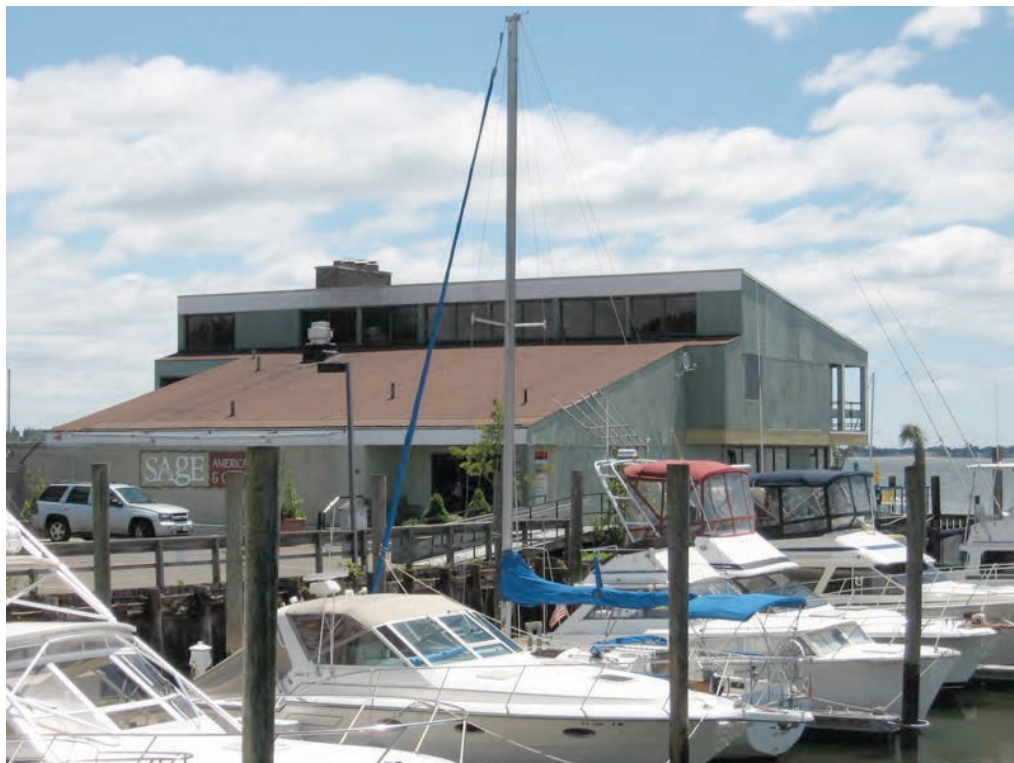
2. Northeast view from entrance drive, camera facing southwest.

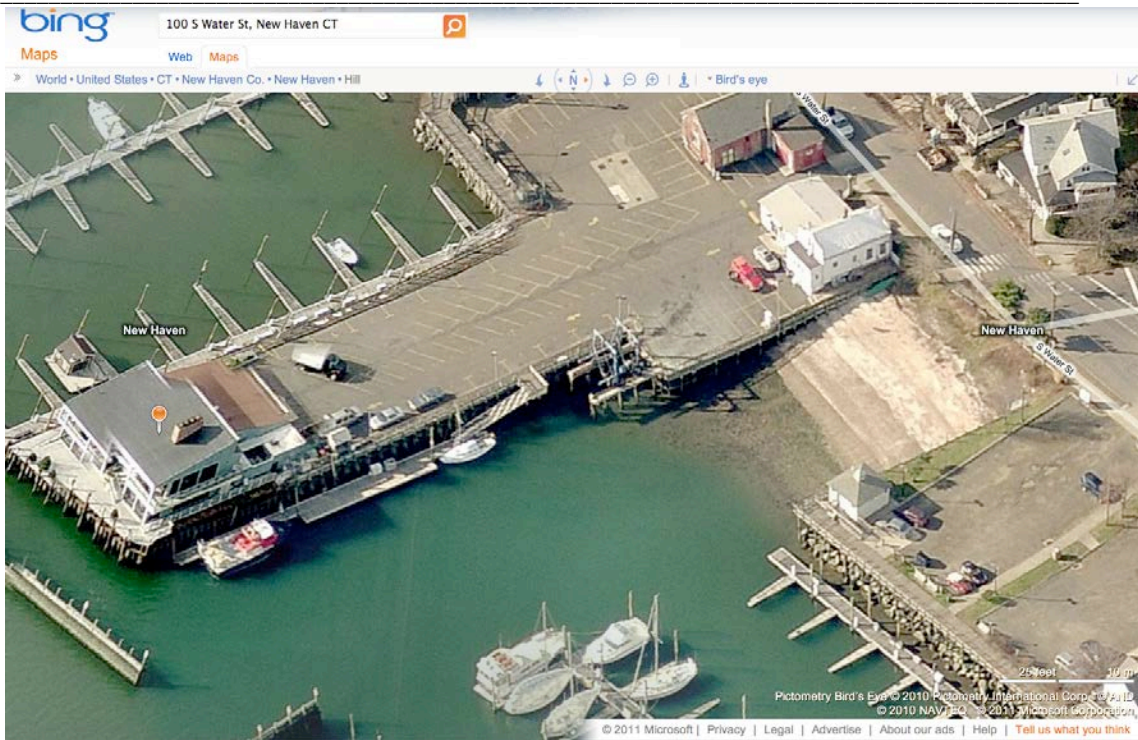
4. East aerial view from Bing Maps <http://www.bing.com/maps/> accessed 6/25/2011.
