HISTORIC RESOURCES INVENTORY - BUILDING AND STRUCTURES

Building Name (Common) William T. Rowe Tower
 Building Name (Historic) William T. Rowe Tower
 Street Address or Location 904-912 Howard Avenue
 Town/City New Haven Village Hill North County New Haven
 Owner(s) Housing Authority of New Haven (HANH) Public Private

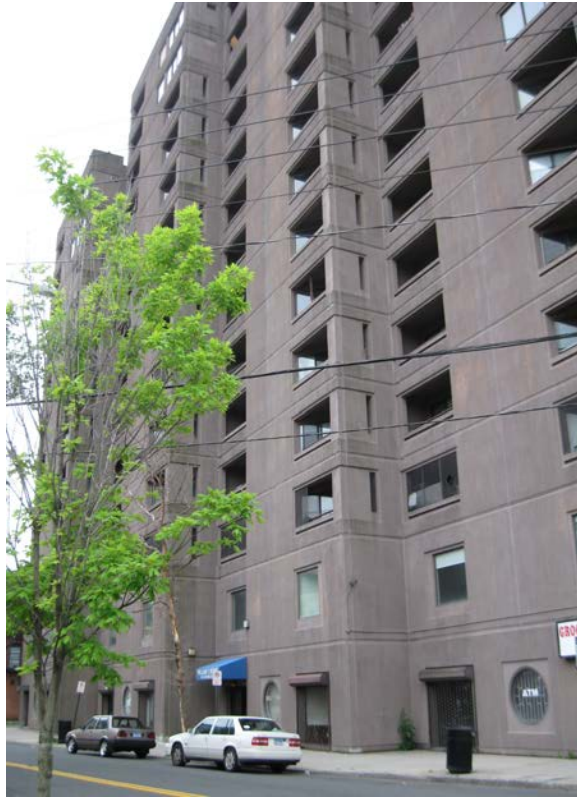
1. East view from Howard Avenue, camera facing southwest.

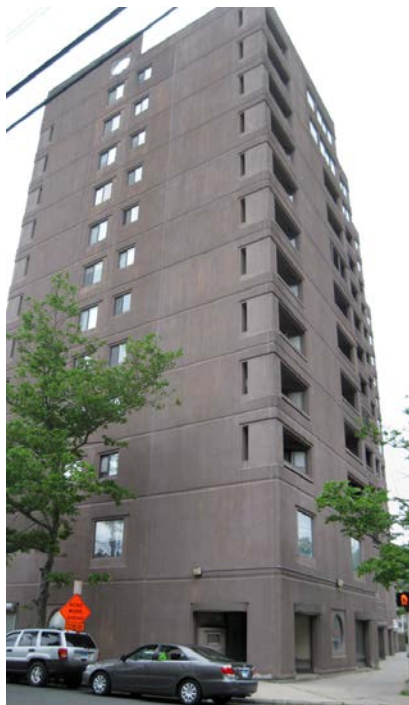
2. Southeast view from corner of Howard Avenue and Sylvan Avenue, camera facing northwest.

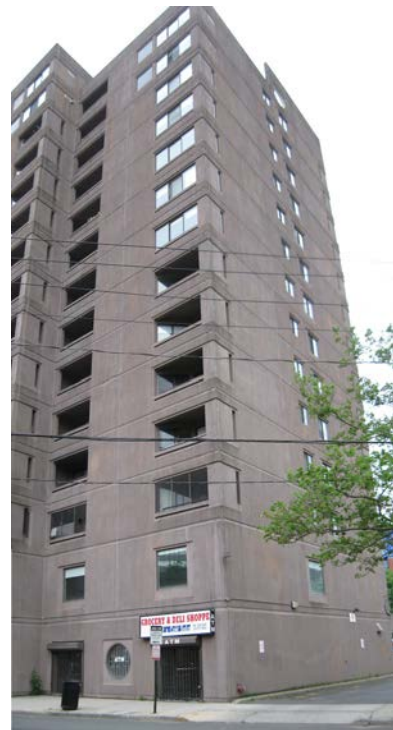
3. Northeast view from Howard Avenue, camera facing southwest.

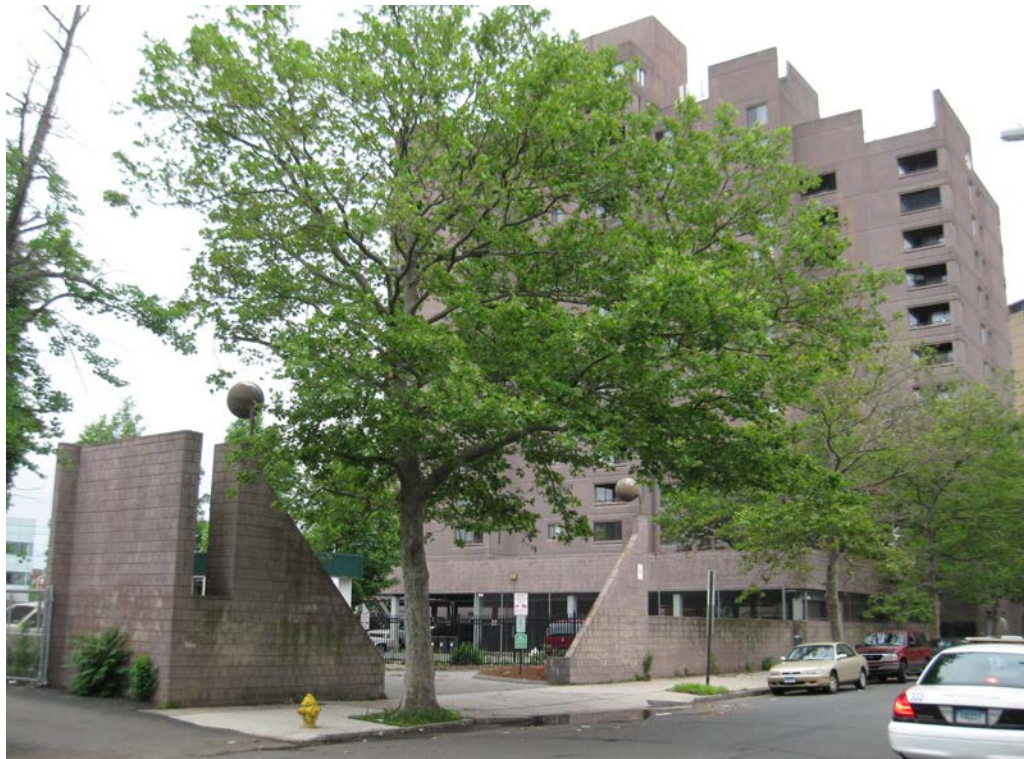
To the west of the building there is a parking garage with a landscaped garden level on its roof. This is connected to the apartment building by a 2nd-floor bridge. Further west on the site is an open parking area which is entered from Sylvan Avenue on the south through a gateway of 8" x 8" scored concrete block masonry, also brown-tinted, sloped up from the curb cut to form wide triangular piers framing the opening.

4. Southwest view from Sylvan Avenue showing parking entrance gateway, parking structure, and building; camera facing northeast.

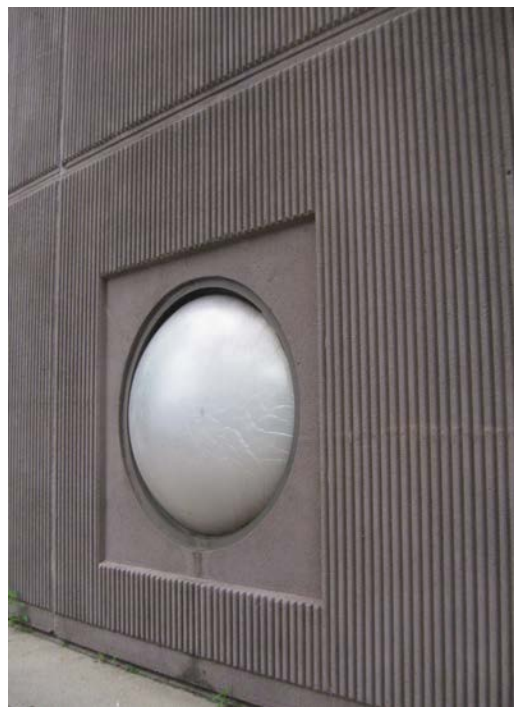
The building is constructed of brown-tinted precast concrete planks and full floor-height panels which are joined by connections at the floor level, utilizing reinforcing bars and concrete infill poured in-situ. Recessed balconies behind some openings and window glazing at the surface plane in others, provide subtle variety. The ground floor has retail spaces, and entries to the upper floors, where storefront openings alternate with large circular openings filled with dome-shaped plastic glazing (some replaced by flat glass), a Post-modern feature in an otherwise Brutalist style design. The second floor has smaller window openings for office space (for the Housing Authority). These two lower floors form a solid podium above which the residential floors, with their larger openings on the east and west elevations, show a greater openness. The north and south elevations have fewer openings, only a pair of unequal-sized windows near the center of the wall. Windows are metal-framed sliding units. Walls are a ribbed textured brown-tinted concrete with an inset reveal indicating the floor levels and a minimalist ornamental recessed panel at the corners. At the roof-level screen wall on both north and south elevations, a large circular opening echoes the ground-floor circular windows.

5. Partial view of south elevation showing precast concrete details and dome window, camera facing northwest.
