HISTORIC RESOURCES INVENTORY FORM

1. BUILDING NAME: Common: Calvary Baptist Church of New Haven Historic: _____
2. TOWN/CITY: New Haven VILLAGE: _____ COUNTY: New Haven
3. STREET & NUMBER (and/or location): 100 Dwight Street
4. OWNER(S): Calvary Baptist Church of New Haven PUBLIC PRIVATE _____
5. USE: Present: Religious Historic: Same
6. ACCESSIBILITY TO PUBLIC: Exterior visible from public road: yes no
Interior accessible: yes, explain Church Services no

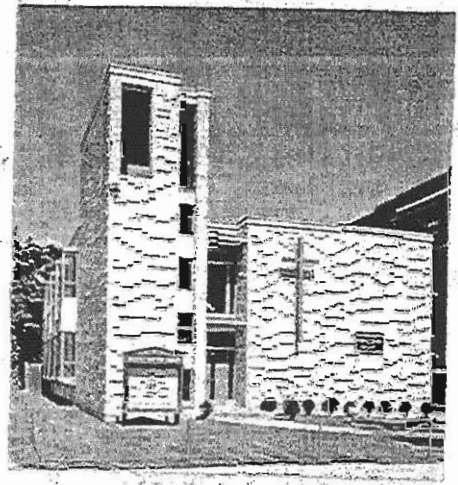
photographer: Thomas Hahn
date: Summer, 1979 view: Southeast corner
negative on file: CHC; CTHP

This white, cut-stone church is rectangular in plan with a 3 storey tower on the southeast corner. Adjacent to the tower on the front (east) facade is the entrance. The double steel doorway has transom above and sidelights. A concrete overhang surmounts this with a large plate glass light above. The remainder of the facade is uninterrupted except by a wooden cross. A band of smooth square concrete blocks cap the walls.

The north elevation has a projecting steel frame bay which supports a wall of concrete into which are set pieces of stained glass.
