HISTORIC RESOURCES INVENTORY - BUILDING AND STRUCTURES

Building Name (Common) East Rock Lodge, IBPOE
 Building Name (Historic) East Rock Lodge, IBPOE
 Street Address or Location 87 Webster Street
 Town/City New Haven Village Dixwell County New Haven
 Owner(s) East Rock Lodge 141 IBPOE of the World, Inc. Public Private

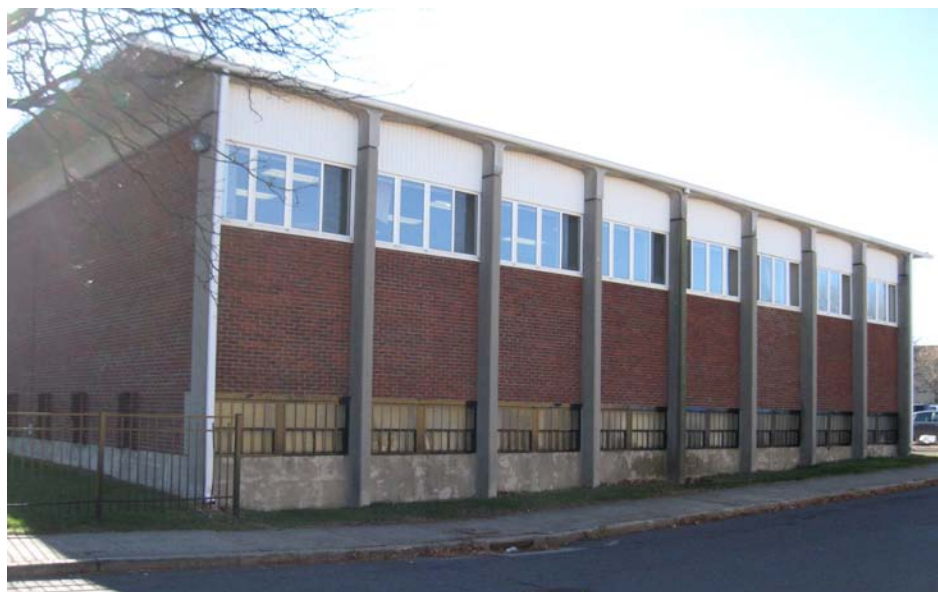
Alterations? Yes No If yes, explain: Window replacement in reduced sizes at north facade.

2. Northeast view from entrance drive, camera facing southwest.
