HISTORIC RESOURCES INVENTORY FORM

For Buildings and Structures

1. BUILDING NAME: Common: _____ Historic: _____
2. TOWN/CITY: New Haven VILLAGE: _____ COUNTY: New Haven
3. STREET & NUMBER (and/or location): 65 Howe Street
4. OWNER(S): Lawrence, Eugene and David Schaffer c/o C.A.White, Inc. PUBLIC PRIVATE
5. USE: Present: Commercial Historic: Same
6. ACCESSIBILITY TO PUBLIC: Exterior visible from public road: yes no
Interior accessible: yes, explain Customers admitted no

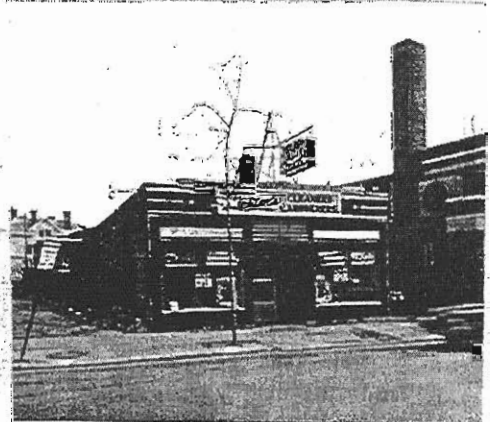
This building is rectangular in plan with a small 1 storey wing to the north. The north and south sides have segmental brick arch windows with projecting brownstone sills. The building has a central entry. The front facade is sheathed in glass panels with horizontal bands of chrome ornament. Directly over the door is an ornamental panel of horizontal chromed members with a central vertical band. The door and 2 large plate glass windows on either side are trimmed in chrome with chrome awning storage covers above.

photographer: Thomas Hahn
date: Fall, 1979 view: Northwest corner
negative on file: CHC; CTHP
