HISTORIC RESOURCES INVENTORY
BUILDING AND STRUCTURES
HIST-6 NEW 5 77

STATE OF CONNECTICUT
CONNECTICUT HISTORICAL COMMISSION
59 SOUTH PROSPECT STREET, HARTFORD, CONNECTICUT 06106
(203) 566-3005

1. BUILDING NAME (Common)	(Historic)	William DeCossy House
2. TOWN/CITY	VILLAGE	COUNTY
New Haven		New Haven
3. STREET AND NUMBER (and/or location)		
269 Ogden Street		
4. OWNER(S)		
Janet G. Slater <input type="checkbox"/> Public <input checked="" type="checkbox"/> Private		
5. USE (Present)		
Residence (Historic) --		
6. ACCESSIBILITY TO PUBLIC:		
EXTERIOR VISIBLE FROM PUBLIC ROAD	INTERIOR ACCESSIBLE	IF YES, EXPLAIN
<input checked="" type="checkbox"/> Yes <input type="checkbox"/> No	<input type="checkbox"/> Yes <input checked="" type="checkbox"/> No

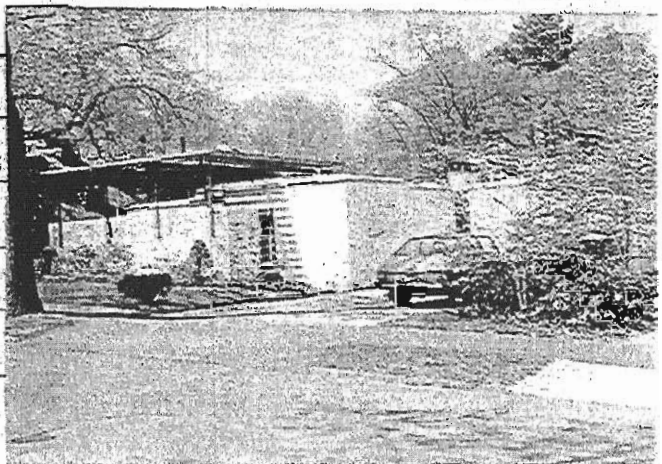
PHOTOGRAPHER: Alan Rutberg DATE: 5/81
 VIEW: Southeast NEGATIVE ON FILE: GNC;NHPT;Sheet #63

This design of interlocking cubes appears small from the street and presents no windows on the facade. A tall, almost 1-story stone wall across most of the facade masks the fenestration of the living area and this wall is repeated as an enclosure around the east side of the driveway. The whitewashed brick enhances the geometric qualities of the design.

Above the main mass on the west side of the house an unpainted wood slat canopy is suspended above the flat roofline on thin vertical members attached to the exterior of the walls -- this canopy combined with the whitewashed walls provides the design with a dramatic light and dark contrast. An attached shed of the same wood construction echoes the canopy element at the west end of the house, at the rear of the driveway. Wings at the north or rear side of the building expand the size of the house which presents a more diminutive appearance to the street.
