CONNECTICUT HISTORICAL COMMISSION59 South Prospect Street, Hartford, Connecticut 06106
(203) 566-3005**HISTORIC RESOURCES INVENTORY FORM**

For Buildings and Structures

1. BUILDING NAME: Common: _____ Historic: _____
2. TOWN/CITY: New Haven VILLAGE: _____ COUNTY: New Haven
3. STREET & NUMBER (and/or location): _____ 9 University Place
4. OWNER(S): Constance Baker Motley PUBLIC PRIVATE
5. USE: Present: Single Family Historic: Same
6. ACCESSIBILITY TO PUBLIC: Exterior visible from public road: yes no
Interior accessible: yes, explain _____

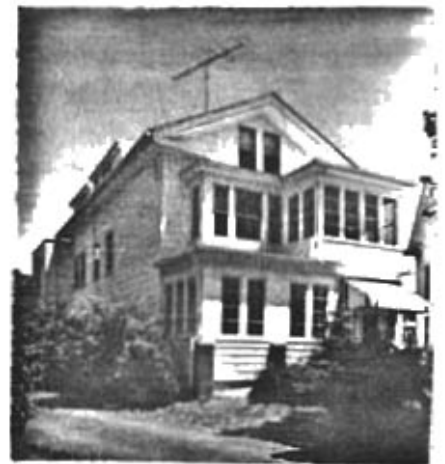
photographer: Thomas Hahn
 date: Fall, 1979 view: Southwest elevation
 negative on file: CHC; CTHP

11. NUMBER OF STORIES: 2½ APPROXIMATE DIMENSIONS: 25' x 60'
12. CONDITION: Structural: excellent good fair deteriorated
 Exterior: excellent good fair deteriorated

13. INTEGRITY: Location: on original site moved, when: 1968-1969
 Alterations: no yes, explain: Re-siding, porches and dormers added
14. RELATED OUTBUILDINGS OR LANDSCAPE FEATURES:
 barn shed garage other landscape features or buildings: _____
 carriage house shop garden _____

A complex grouping of enclosed, 2 storey Colonial Revival porch additions dominates the facade of this 2½ storey, 3 bay building. The wide soffit with deep return and paired gable windows remain visible. Shed dormers and rear additions also appear.

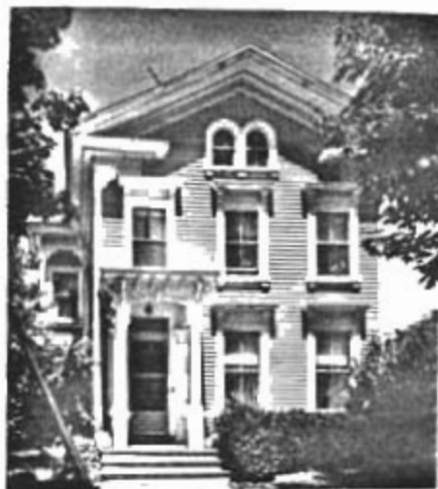
photographer: Thomas Hahndate: Fall, 1979 view: South elevationnegative on file: CHC; CTHP

This "L"-shaped building has a 2 storey octagonal bay on its east elevation. The gable ends have a heavy wide soffit, lined with reel moulding, which forms a deep cornice return. Moulded frames and heavy sills surround paired, round arched gable windows. The facade windows are further accented by tall pedimented lintels on brackets with bosses on the frieze. Italianate corner boards frame the building. The tall flat-roofed entry porch on chamfered posts features attractive cutwork corner brackets and other detailing. The building's west elevation shows a multi-paned colored glass stair light.

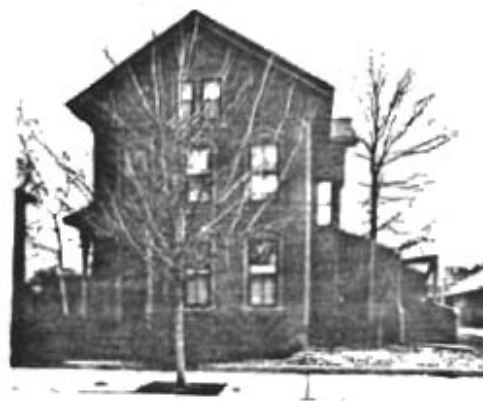
photographer: Thomas Hahndate Fall, 1979 view. South elevationnegative on file: CHC; CTHP

This 2½ storey building is sheathed in board and batten in its gable ends to the sill level of its paired gable windows. Hammerbrace brackets support the overhanging eaves. The 2/2 windows have center-peaked moulded frames and flat bracketed sills. The entry porch with its tall gabled roof has board and batten and brackets like the main gable end. A segmented arch transom light stands above the period door. A complex single storey addition which includes an entrance stands on the building's east side.

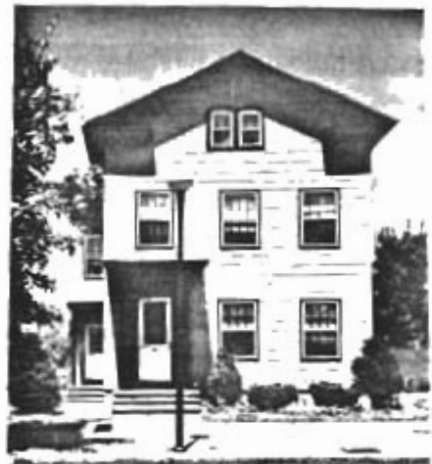
photographer: Thomas Hahn
 date: Fall, 1979 view: South elevation
 negative on file: CHC; CTHP

11. NUMBER OF STORIES: 2½ APPROXIMATE DIMENSIONS: 30' x 60'
12. CONDITION: Structural: excellent good fair deteriorated
 Exterior: excellent good fair deteriorated

13. INTEGRITY: Location: on original site moved, when: 1968-1969
 Alterations: no yes, explain: Windows replaced, re-siding
14. RELATED OUTBUILDINGS OR LANDSCAPE FEATURES:
 barn shed garage other landscape features or buildings: _____
 carriage house shop garden _____

This building, 3 bays wide, includes an additional entrance in the western "L". The wide soffit with deep return frames paired segmented arch gable windows. The heavy flat-roofed entry porch is supported on square columns. An arched, multi-paned stair window appears on the west elevation.

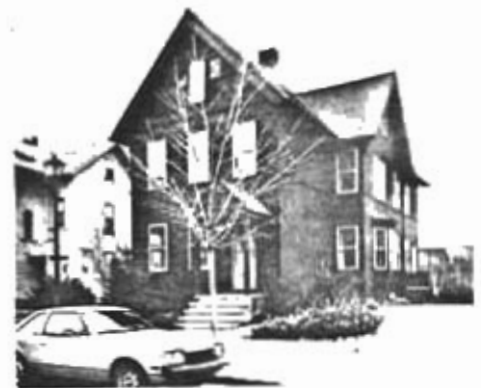
photographer: Thomas Hahndate: Fall, 1979 view: South elevationnegative on file: CHC; CTHP

11. NUMBER OF STORIES: 2½ APPROXIMATE DIMENSIONS: 25' x 50'
12. CONDITION. Structural: excellent _____ good _____ fair _____ deteriorated
 Exterior: excellent _____ good _____ fair _____ deteriorated

13. INTEGRITY: Location: on original site moved, when: 1968-1969
 Alterations: no yes, explain: Entry porch replaced
14. RELATED OUTBUILDINGS OR LANDSCAPE FEATURES:
 _____ barn _____ shed _____ garage _____ other landscape features or buildings: _____
 _____ carriage house _____ shop _____ garden _____

This building has a full east-west cross gable section which protrudes 1 bay on each side. Solid bargeboards and carved rafter ends surround its gable end sheathed in sawtooth shingle. Square multi-paned windows flank the gable window. A line of dentils and flat, applied swags embellish the gable line above the 2nd storey lights. The gabled entry porch on plain posts is a replacement.

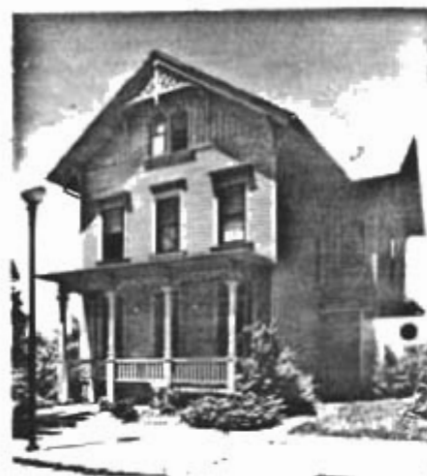
photographer: Thomas Hahn
 date: Fall, 1979 view: South elevation
 negative on file: CHC; CTHP

11. NUMBER OF STORIES: 2½ APPROXIMATE DIMENSIONS: 25' x 60'
12. CONDITION: Structural: excellent _____ good _____ fair _____ deteriorated
 Exterior: excellent _____ good _____ fair _____ deteriorated

This building features wide overhanging eaves supported by large stick brackets, a gable apron of good art work design on a cross piece with drop finial, and board and batten sheathed gable ends bordered by a row of applied drop ornament. The paired, clipped-corner windows rest on heavy bracketed sills, as do the remaining 2/2 windows. Pedimented hoods on brackets shield the 2nd storey lights. The flat-roofed front porch stands on chamfered posts and features a wide soffit, brackets and delicate incised frieze trim.
