## HISTORIC RESOURCES INVENTORY - BUILDING AND STRUCTURES

Building Name (Common) Knights of Columbus Museum

Building Name (Historic) Community Services Building

Street Address or Location 1 State Street

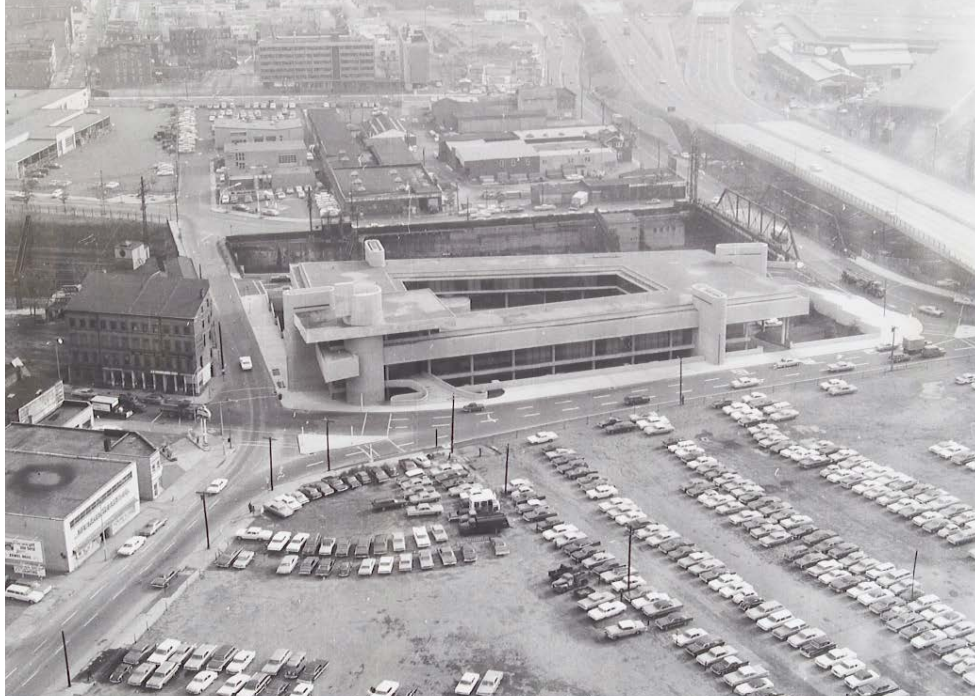
Photo 4. West aerial view of 1 State Street, camera facing east. Date approximately 1967, prior to construction of the Coliseum. Photo from New Haven Redevelopment Collection, New Haven Museum.

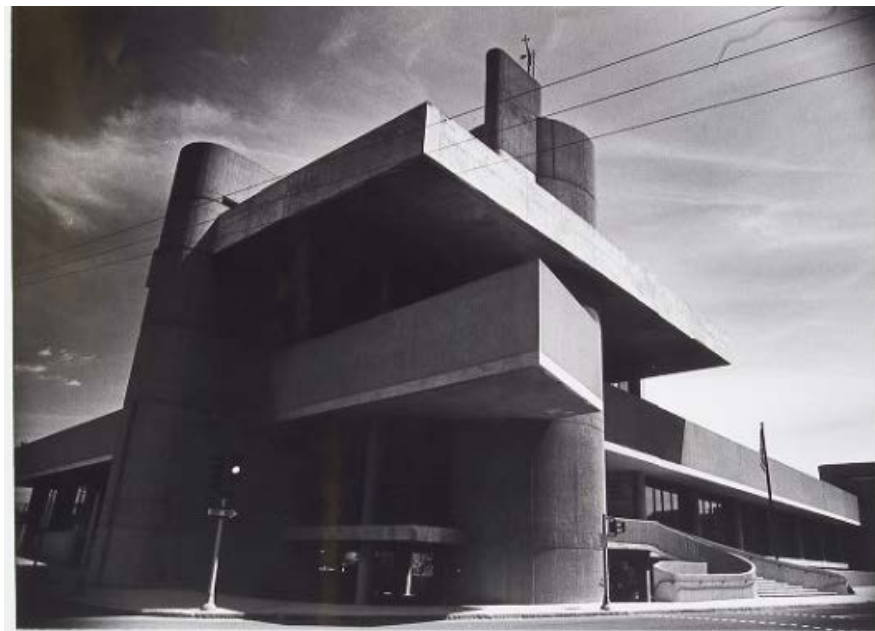
Photo 5. Northwest historical view of Community Services Building in 1971, camera facing southeast. New Haven Redevelopment Collection, New Haven Museum.

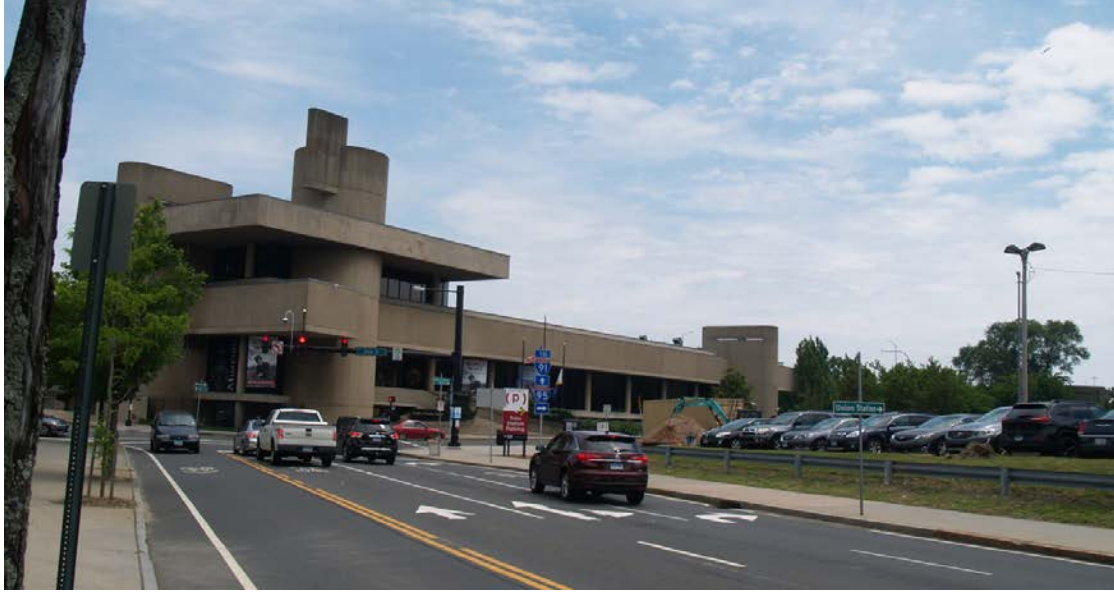
Photo 6. Northwest view of 1 State Street, camera facing southeast along George Street.

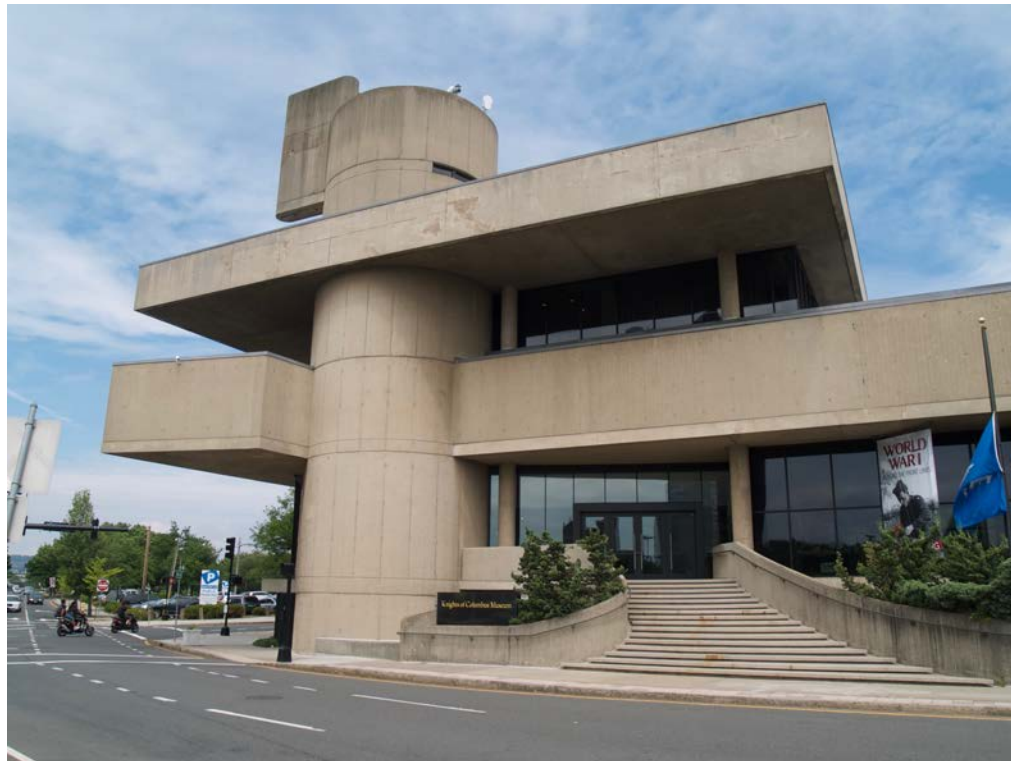
Photo 7. West detail view of 1 State Street, camera facing east, showing the main entrance and sculptural massing at the northwest corner.

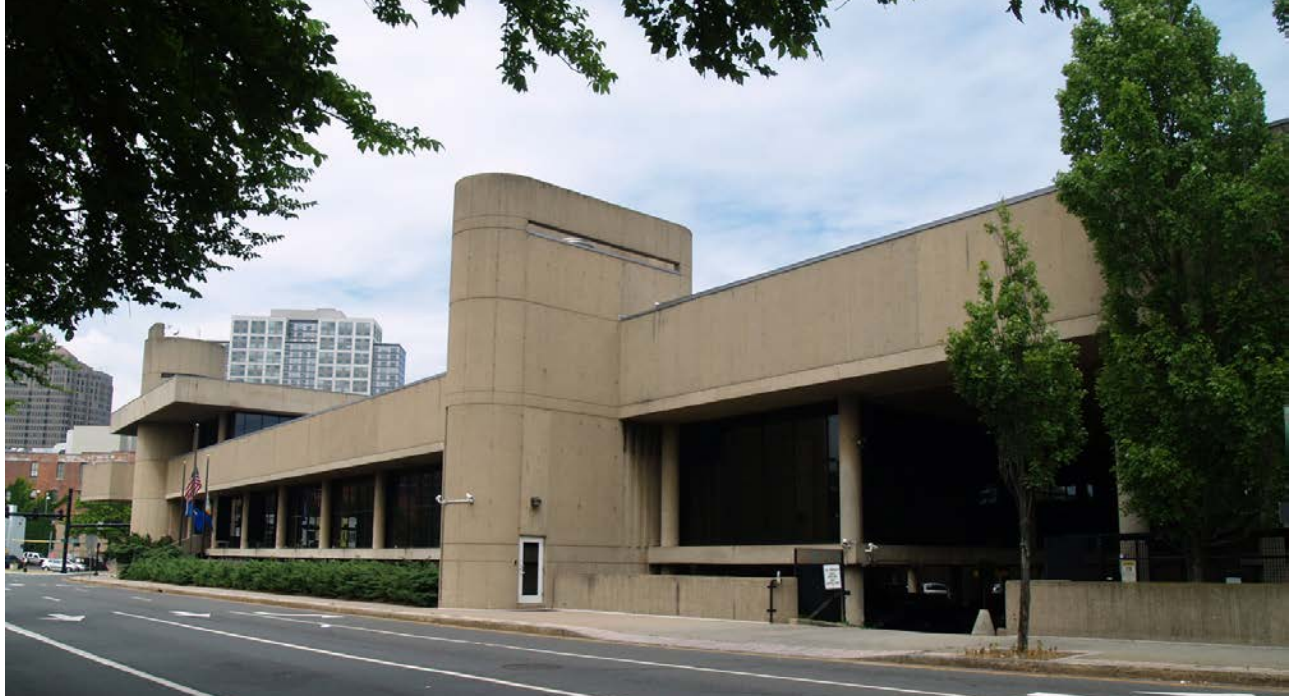
Photo 8. Southwest view of 1 State Street, camera facing northeast along State Street. The parking entrance drive is at right.

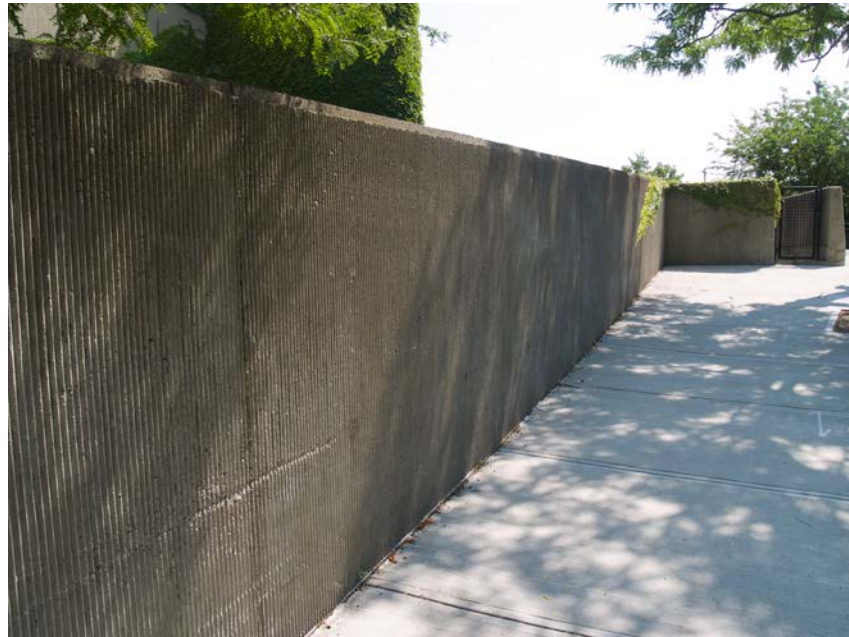
Photo 9. South detail view of the perimeter wall, camera facing east. The finish of exposed concrete is a narrow ribbed texture which gives the building a surprising refinement, contrasting with the hardness of the material.

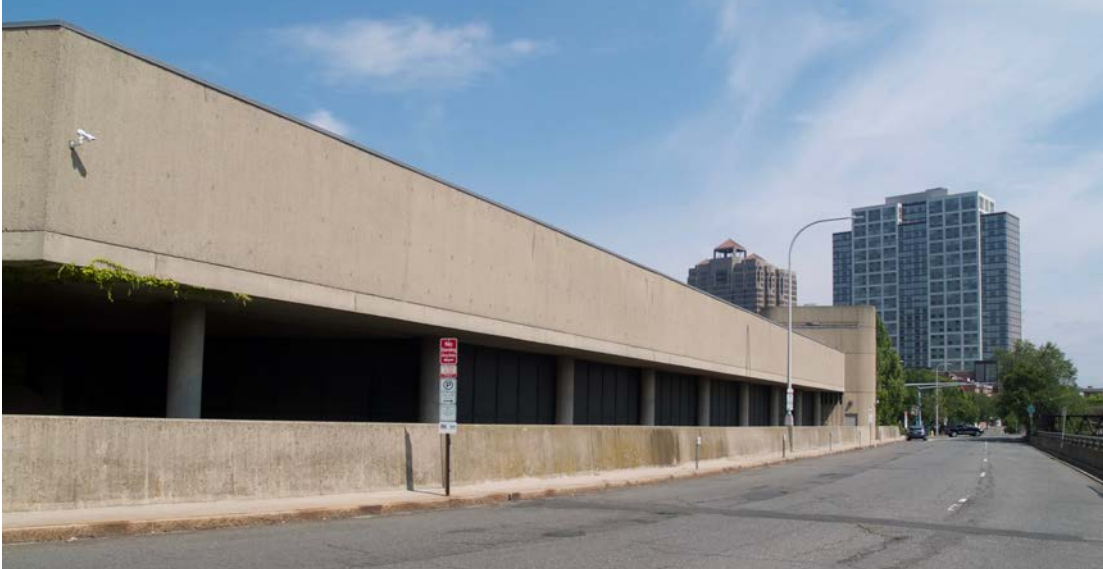
Photo 10. East view of 1 State Street, camera facing north.

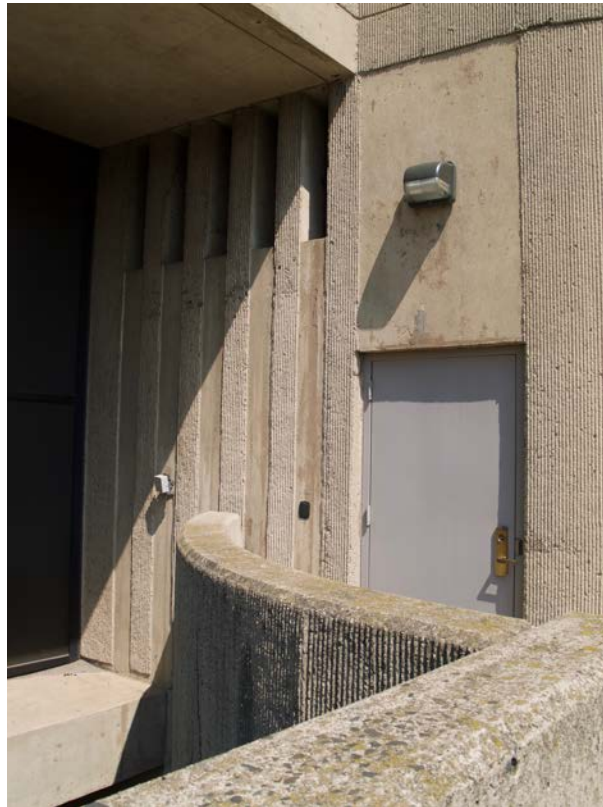
Photo 11. South view of east stair exit to State St. North, camera facing northwest, showing concrete details.

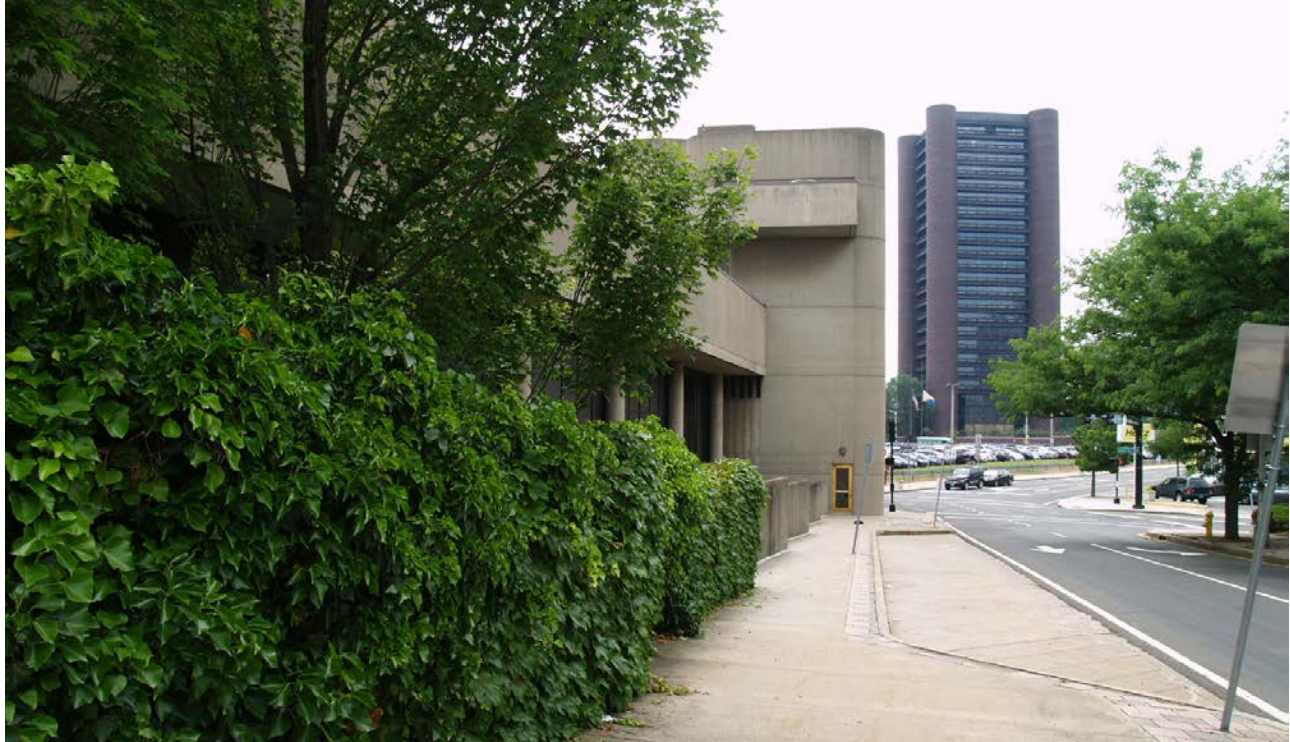
Photo 12. North view, camera facing west, showing the building corner with the Knights of Columbus headquarters at 1 Columbus Plaza in the distance beyond the former Coliseum site.

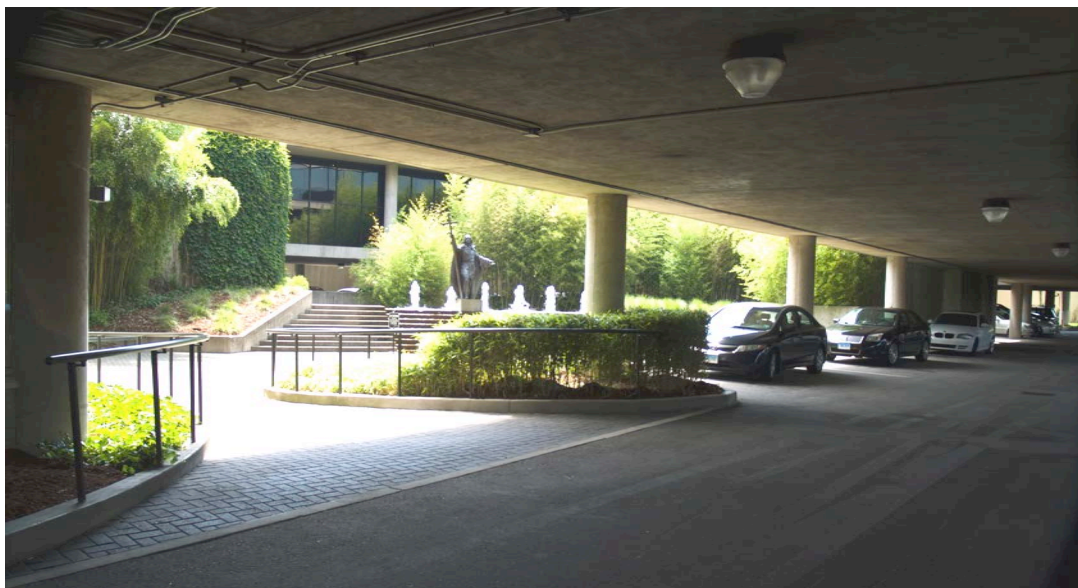
Photo 13. Lower level view of parking and courtyard, camera facing southeast.

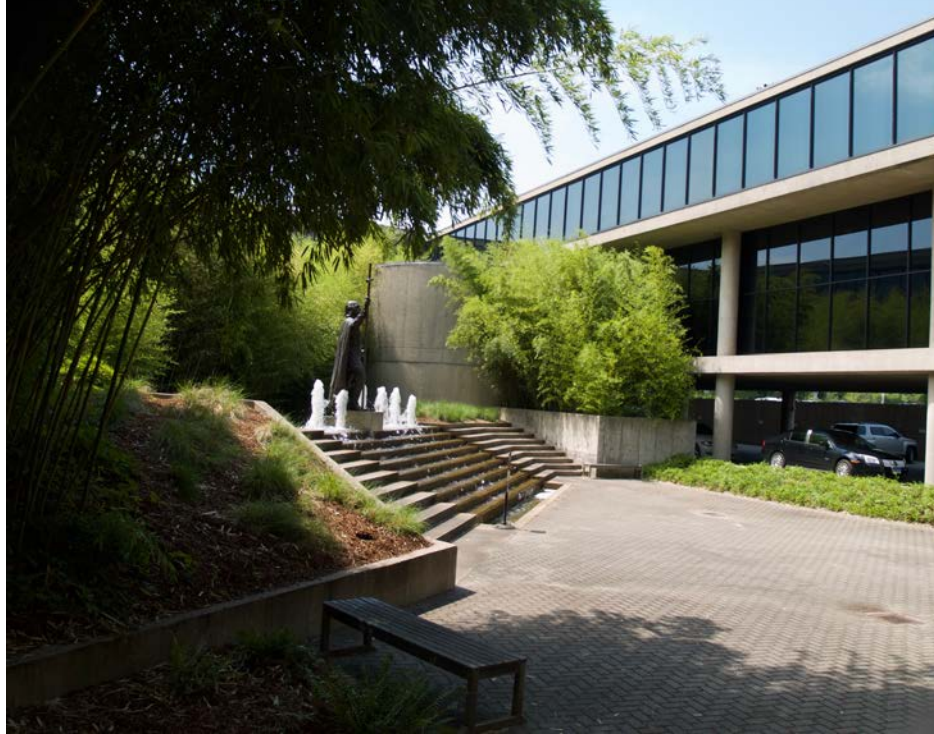
Photo 14. Lower level view of courtyard, camera facing southwest.

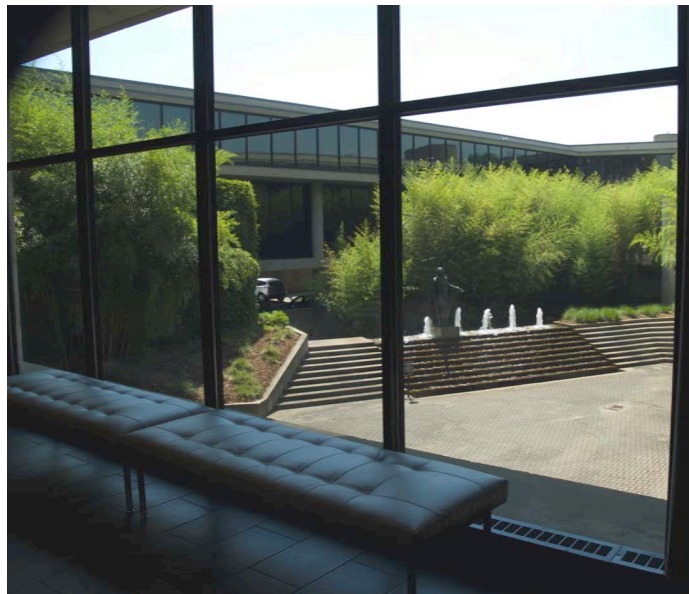
Photo 15. Interior first floor view of courtyard, camera facing southeast.

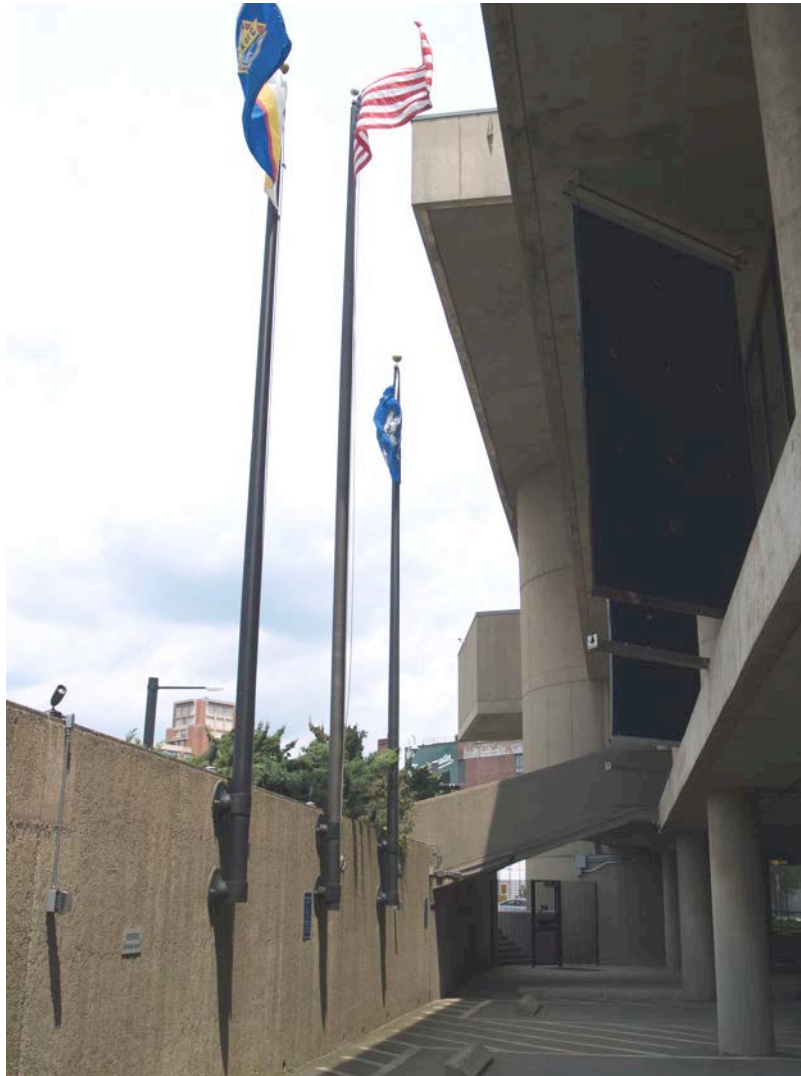
Photo 16. Lower level view of parking and side view of the entry stair, camera facing north, showing the relationship of the sunken parking level to street and first floor elevations.
