Prospect Hill 219-460-3

1. BUILDING NAME (Common) (Historic)
John E. Heaton Carriage House

3. STREET AND NUMBER (and/or location)
21 Autumn Street

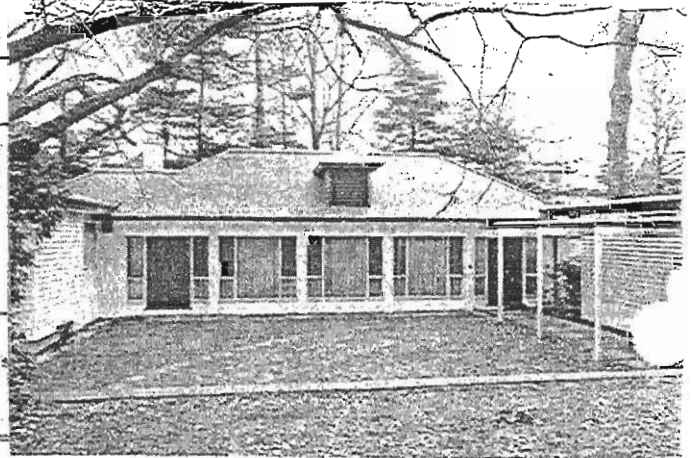
VIEW: Northwest NEGATIVE ON FILE: CHC;NHPT;Sheet no. 54

Originally a long, low rectangular structure; recent additions to the south (wing) and north (attached garage) create an irregular U-shape plan around a private and informally planted front courtyard. The principal extant original feature of the carriage house is a major, central, hip-roof dormer with louvered front.

All exterior walls now combine modern floor-to-ceiling glass windows, glass doors (double at entrance) and flat, white wall surfaces.
