**HISTORIC RESOURCES INVENTORY  
BUILDING AND STRUCTURES**  
HIST-6 NEW 5 77

**Yale Central Complex** 206-307-18

1. BUILDING NAME (Common) (Historic)	
Yale Co-op Yale Co-op	
2. TOWN/CITY	VILLAGE COUNTY
New Haven	New Haven
3. STREET AND NUMBER (and or location)	
77 Broadway

HISTORIC RESOURCES INVENTORY FORM  
For Buildings and Structures

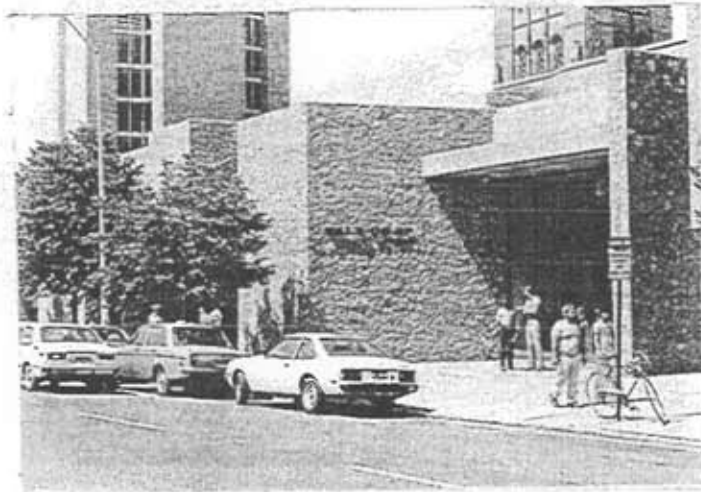
Ext: 5-bay facade includes large entrances at each end of the building. The entrances are recessed under concrete canopies, and have quadruple glass doors. 3 identical shop windows comprising center of facade are also recessed within the wall. Rectangular sections of masonry project over them and out from the facade wall, from the tops of the windows to the roof line.

- 19) In particular, the Co-op storefront mediates between the very broken and irregular massing of the rear college buildings, and the scale, cornice line and facade line of Broadway (north side).
