HISTORIC RESOURCES INVENTORY FORM

1. BUILDING NAME: Common: St. Michael's Ukranian Catholic Church Historic: Same
2. TOWN/CITY: New Haven VILLAGE: ----- COUNTY: New Haven
3. STREET & NUMBER (and/or location): 563 George Street
4. OWNER(S): The Diocese of the Byzantine Rite PUBLIC PRIVATE
5. USE: Present: Religious Historic: Same
6. ACCESSIBILITY TO PUBLIC: Exterior visible from public road: yes no
Interior accessible: yes, explain Religious services no

7. STYLE OF BUILDING: Contemporary with Neo-Byzantine elements DATE OF CONSTRUCTION: 1958
8. MATERIAL(S) (indicate use or location when appropriate):
 clapboard asbestos siding brick
 wood shingle asphalt siding fieldstone
 board & batten stucco cobblestone
 aluminum siding concrete: type: _____ cut stone: type: _____
 other: _____

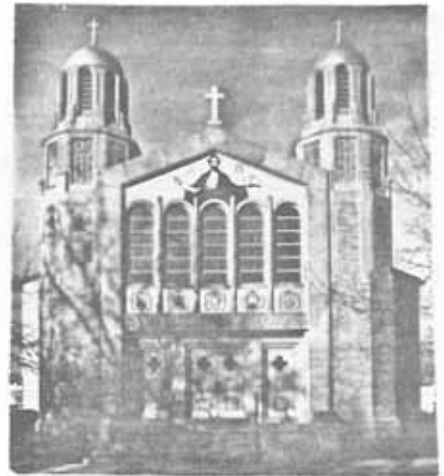
PHOTOGRAPH

This rectangular church presents an impressive facade. A gabled center section is flanked by 2 octagonal towers capped with gold leaf dome roofs and finials in the shape of Crosses. The top of the towers feature arched ventilators. Below these and level with the gable peak are sculpted relief panels showing vineyards and harvests of wheat. The center section is framed by stone panels slightly projecting. A row of tall round-arched windows of stained glass line the 2nd storey. Above and below these windows are mosaic panels. The upper mosaic is an illustration of Christ, the teacher, set on a gold background. Below each window is a mosaic shield. The entrance features slightly recessed doors with lintels incised with grape vines. To the rear of the church extends a large educational wing and garages.

photographer: Thomas Hahndate: Fall, 1979 view: South elevationnegative on file: CHC; CTHP
