HISTORIC RESOURCES INVENTORY  
BUILDING AND STRUCTURES  
HIST-6 NEW 5/77

Long Wharf

1. BUILDING NAME (Common)	(Historic)
Community Health Care Center	Same
2. TOWN/CITY	VILLAGE COUNTY
New Haven	New Haven
3. STREET AND NUMBER (and or location)	
150 Sargent Drive	
4. OWNER(S)	<input type="checkbox"/> Public <input checked="" type="checkbox"/> Private
Community Health Care Center Plan, Inc.	
5. USE (Present)	(Historic)
Medical facility	Same
6. ACCESSIBILITY TO PUBLIC:	EXTERIOR VISIBLE FROM PUBLIC ROAD INTERIOR ACCESSIBLE IF YES, EXPLAIN
<input checked="" type="checkbox"/> Yes <input type="checkbox"/> No	<input checked="" type="checkbox"/> Yes <input type="checkbox"/> No Office hours

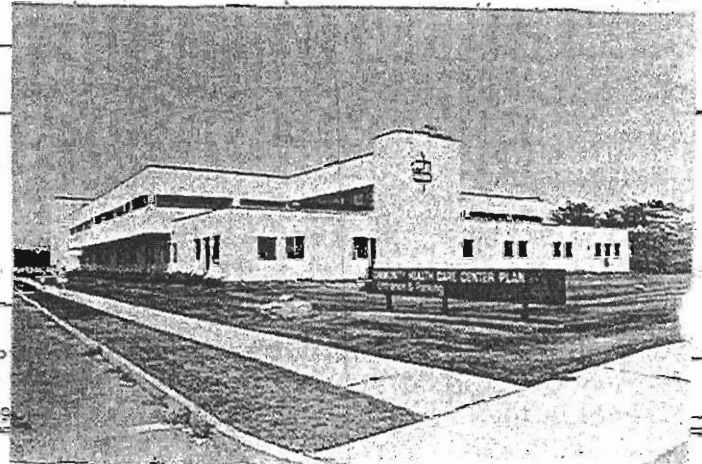
Photograph

White planar walls contrast with bands of dark glass windows, features typical of International Style design. Horizontal sections of building housing distinct functions are accented by 3 vertical (windowless) stairhall towers around the building. The tallest tower on the Sargent Drive facade carries the center's logo, and acts as a distinguishing facade feature in the absence of an entrance detail on this side.

PHOTOGRAPHER	ROGER BALDWIN; ALAN RUTBERG	DATE	1/78/81; 2/5/80
VIEW	1) southeast; 2) west	NEGATIVE ON FILE	74;
NAME	Susan Ryan	DATE	7/80
ORGANIZATION	New Haven Preservation Trust		
ADDRESS	P.O. Box 1671, New Haven, CT 06507

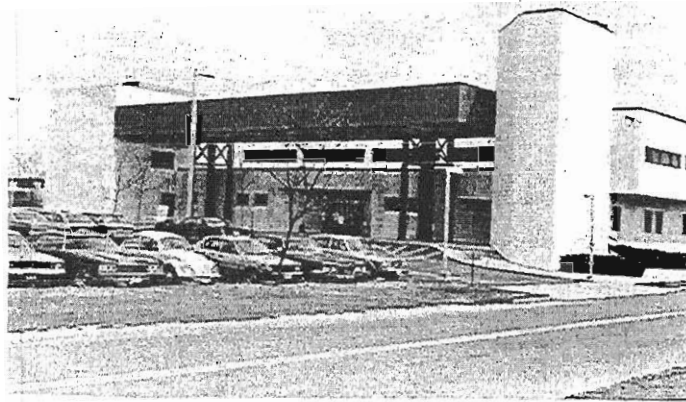
CONTINUATION SHEET

Rear (parking lot side): steel-trussed frame entrance canopy, for the convenience of patients in inclement weather, exaggerated for design purposes.

Community Health Care Center  
150 Sargent Drive
