HISTORIC RESOURCES INVENTORY - BUILDING AND STRUCTURES

Building Name (Common) Creative Arts Workshop
 Building Name (Historic) Creative Arts Workshop
 Street Address or Location 80 Audubon Street
 Town/City New Haven Village _____ County New Haven
 Owner(s) Arts Council of Greater New Haven Public Private

80 Audubon Street, New Haven CT

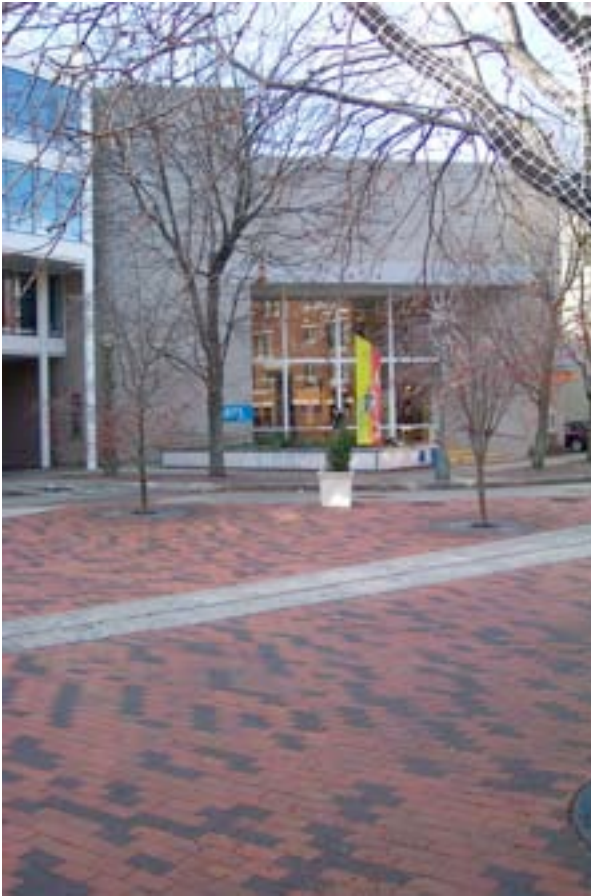
1. North entry facade from the plaza on Audubon Street, camera facing southwest.

The front (north) facade continues the street wall formed by the adjacent Neighborhood Music School, but in a light gray concrete masonry construction. The facade angles 45 degrees to form one side of the plaza, which opens at the center of the block. Two massive vertical elements anchor the corners of the facade, with a heavy lintel formed by the third floor. Below this, a double-height glass wall showcases the exhibit gallery located inside the front of the building. The gallery includes a mezzanine level pulled back from the facade to allow a two-story high space next to the glass wall. The building entry is tucked into the left (east) side of the facade. Behind the gallery, the building extends as a long narrow block, forming the east wall enclosing the Park of the Arts. On the top floor, saw-tooth skylights bring light into the studio spaces.

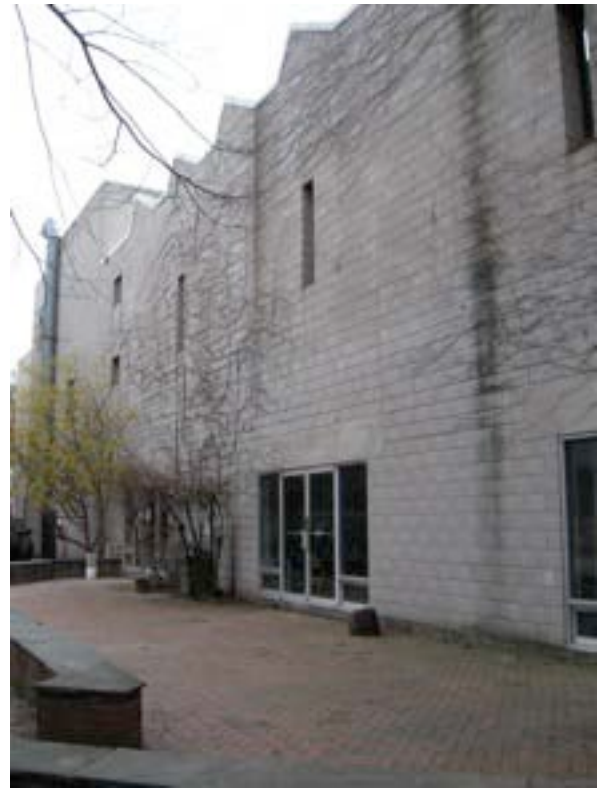
2. West façade facing Park of the Arts, camera facing north.

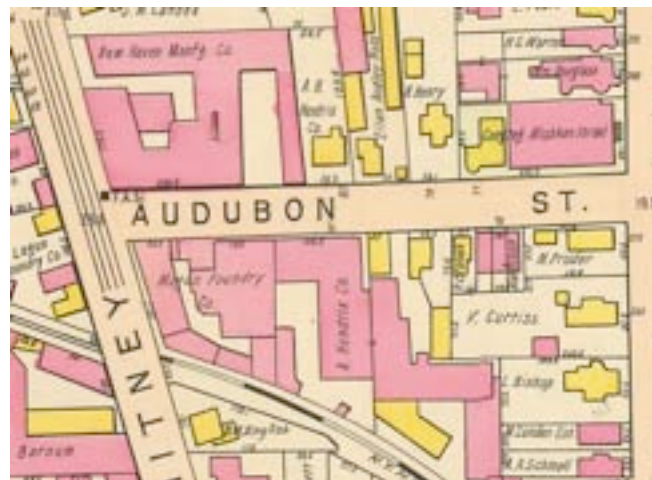
3. 1911 Map of Audubon Street, showing factories located along the railroad line prior to the Redevelopment period, and Temple Mishkan Israel at the corner of Audubon and Orange Streets. Atlas of New Haven Connecticut 1911 by Walker Lithograph & Publishing Co.

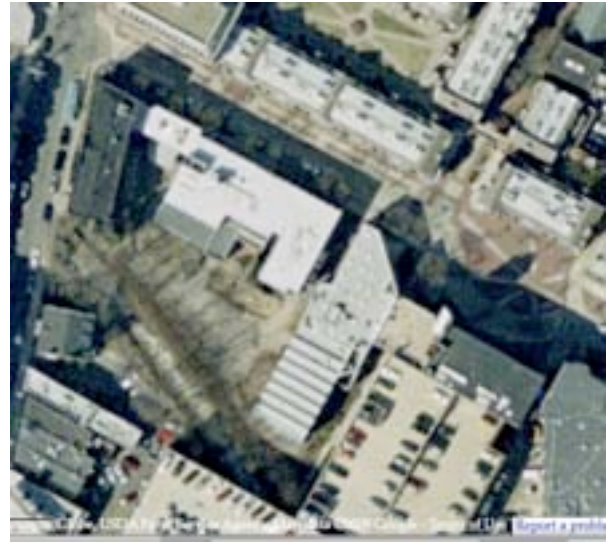
5. Aerial view from Google Maps; sawtooth skylights
are visible on the rear portion of the roof.

The first phase, a one-story structure of load-bearing concrete block with an exposed ribbed surface and pre-cast concrete plank floor construction, was designed for additional floors. In 1978, King-Lui Wu designed the second story addition with seven canted north-facing saw-tooth skylights, framed in steel columns and beams, and a steel fire escape stair. These were superimposed on the original one-story element with continuous exterior finishes camouflaging the joint of older and newer.
