HISTORIC RESOURCES INVENTORY
BUILDING AND STRUCTURES

1. BUILDING NAME (Common) (Historic)
 Holy Transfiguration

3. STREET AND NUMBER (and/or location)
 285 Alden Avenue (N.E. Corner of Burton Street)

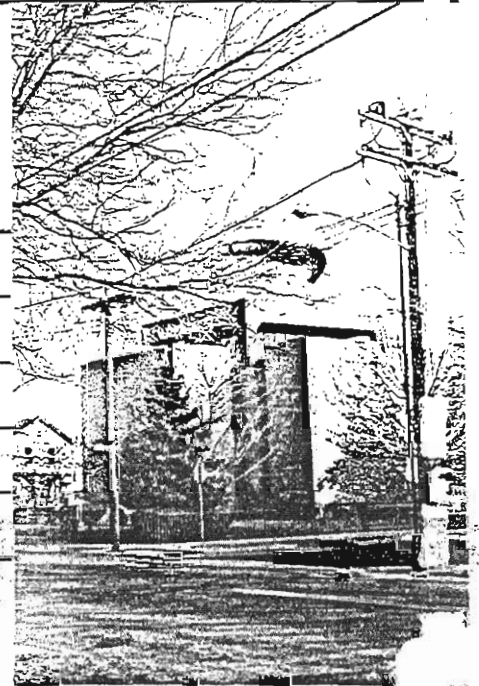
SW

Building: A 1 story reinforced concrete Brutalist style Russian Orthodox Church with basically a flat roof shape. The building is a series of rectangular and square boxes. The square shape main section of the church has glazed walls. In front of the glazed wall are large concrete blocks giving support to the main body of the church. The dominate feature of the building is the gold leaf "onion" or Russian style dome. The dome is topped by a finial. The entrance is recessed under a round arched opening. Above the door, there is a painting depicting the Transfiguration.

Architectural: Holy Transfiguration Church is an architecturally unusual building for New Haven. The building is a combination of the Brutalist style and traditional Russian architectural forms as seen in the dome.
