STATE OF CONNECTICUT
 CONNECTICUT HISTORICAL COMMISSION

1. BUILDING NAME (Common) (Historic)	
2. TOWN/CITY New Haven	VILLAGE COUNTY New Haven
3. STREET AND NUMBER (and or location) 130-136 Button St.	
4. OWNER(S) City of New Haven, Housing Authority <input checked="" type="checkbox"/> Public <input type="checkbox"/> Private

7. STYLE OF BUILDING Post-Modern	DATE OF CONSTRUCTION 1976
8. MATERIAL(S) (Indicate use or location when appropriate)	
<input type="checkbox"/> Clapboard <input type="checkbox"/> Wood Shingle <input checked="" type="checkbox"/> Board & Batten <input type="checkbox"/> Aluminum Siding	<input type="checkbox"/> Asbestos Siding <input type="checkbox"/> Asphalt Siding <input type="checkbox"/> Stucco <input type="checkbox"/> Concrete Type: _____
<input type="checkbox"/> Brick <input type="checkbox"/> Fieldstone <input type="checkbox"/> Cobblestone <input type="checkbox"/> Cut stone Type: _____	<input type="checkbox"/> Other (Specify) _____

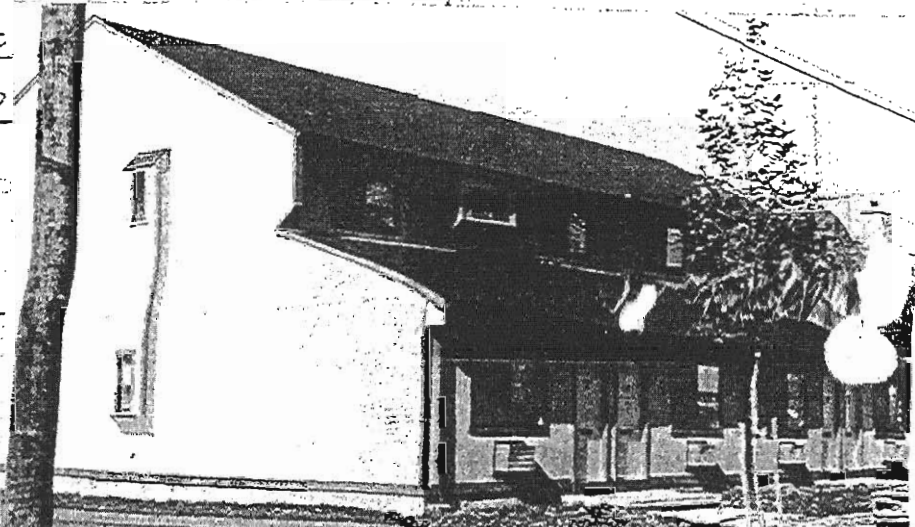
East (front)

11. NUMBER OF STORIES APPROXIMATE DIMENSIONS 2&A&B Each unit: 20' X 35'	
12. CONDITION (Structural) (Exterior)	
<input checked="" type="checkbox"/> Excellent <input type="checkbox"/> Good <input type="checkbox"/> Fair <input type="checkbox"/> Deteriorated	<input checked="" type="checkbox"/> Excellent <input type="checkbox"/> Good <input type="checkbox"/> Fair <input type="checkbox"/> Deteriorated

Building: One of many multi-family units constructed in the center of the Hill. This is a typical example. Consists of a four unit structure 2 stories with pitched roof. Smaller (one story) shed extends protrude from front and rear faces. Entry doors are grouped in pairs. Windows are single light, aluminum track. Siding is a plywood paneling. Other units have one or three stories.
