HISTORIC RESOURCES INVENTORY
BUILDING AND STRUCTURES
 HIST-6 NEWS 77

Yale Central Complex 280-286-7

1. BUILDING NAME (Common)		(Historic)	
Christ Church Parish House		Same	
2. TOWN/CITY		VILLAGE	
New Haven		New Haven	
3. STREET AND NUMBER (and or location)			
84 Broadway (rear on Elm Street)			
4. OWNER(S)			
Society of Christ Church Parish <input type="checkbox"/> Public <input checked="" type="checkbox"/> Private			
5. USE (Present)		(Historic)	
Religious offices		Same	
6. ACCESSIBILITY TO PUBLIC:		EXTERIOR VISIBLE FROM PUBLIC ROAD	
<input checked="" type="checkbox"/> Yes <input type="checkbox"/> No		<input checked="" type="checkbox"/> Yes <input type="checkbox"/> No	
		INTERIOR ACCESSIBLE	
		<input checked="" type="checkbox"/> Yes <input type="checkbox"/> No	
		IF YES, EXPLAIN	
		Office hours

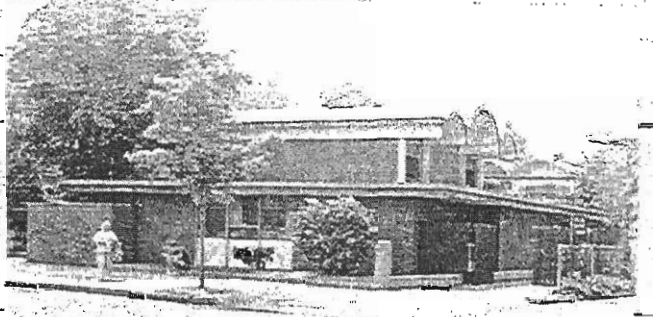
Photograph

The building consists of a large, rectangular brick-walled 1st story running through to Elm Street. Broadly-projecting eaves above the 1st story give a strongly horizontal feeling to the base of the design. Above, 2 2nd-story sections are topped by multiple concrete barrel vaults. The section on Broadway is sited with the vaults running parallel to the street. The 3-bay section has a larger central vault between 2 smaller side vaults, extended well beyond the end walls of the 2nd-story section. The vaults are slightly different in dimension on the Elm Street side and run at right angles to the street. There is a built-in garage area on Elm Street.

VIEW
North
