STATE OF CONNECTICUT
CONNECTICUT HISTORICAL COMMISSION
 59 SOUTH PROSPECT STREET, HARTFORD, CONNECTICUT 06106
 (203) 566-3005

1. BUILDING NAME (Common) (Historic)
 Ralph Affinto House

3. STREET AND NUMBER (and/or location)
 1850 Boulevard

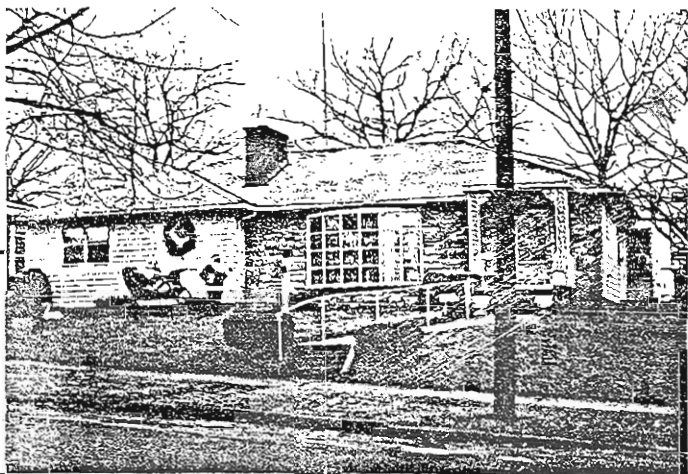
Building: A one story Contractor Modern style structure with a hip roof, large brick chimney, multi-paned "bow" facade window, cut stone facing on the northern portion of the facade, and wrought iron porch supports. Note the wing on the southern elevation, which incorporates a garage within it.
