HISTORIC RESOURCES INVENTORY FORM  
For Buildings and Structures

- 1. BUILDING NAME: Common: \_\_\_\_\_ Historic: \_\_\_\_\_
- 2. TOWN/CITY: New Haven VILLAGE: \_\_\_\_\_ COUNTY: New Haven
- 3. STREET & NUMBER (and/or location): 1203-1215 Chapel Street
- 4. OWNER(S): Eld Realty Incorporated PUBLIC  PRIVATE
- 5. USE: Present: Commercial and Office Historic: Same
- 6. ACCESSIBILITY TO PUBLIC: Exterior visible from public road:  yes  no  
Interior accessible:  yes, explain Customers admitted  no

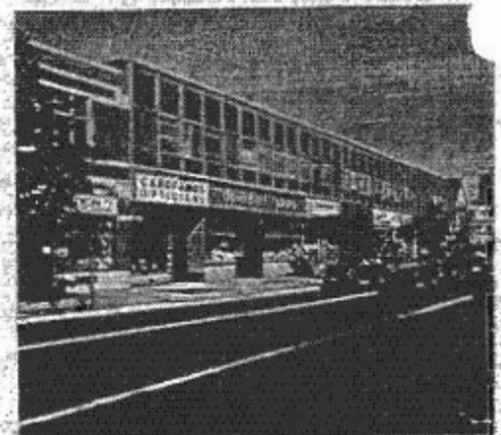
## PHOTOGRAPH

This 2 storey building has offices on the upper floor and storefronts below. The upper storey consists of a horizontal window band broken by vertical aluminum strips and bordered by equal-width bands of gray aluminum panels above and below. Below this conventional office wall treatment are 8 storefronts in 2 distinct groups on either side of the entrance to the office level. The 4 western fronts, faced in yellow brick, each angle deeply into the building on one end to form recessed doors. The 4 eastern fronts have Moderne styling. Faced in an off-white composite, this eastern half is accented by narrow green bands above the windows and has, in the Art Deco manner, ionic pilasters. In the foundation facing, geometric cut-out designs form ventilation ducts.

Despite the distinct styles of the 2 halves of this building, it was apparently built as one. The Moderne eastern half is rather nice, especially for its attractive duct screens.

photographer: Thomas Hahndate: Fall, 1979 view: South elevationnegative on file: CHC:CTHP
