HISTORIC RESOURCES INVENTORY FORM

For Buildings and Structures

1. BUILDING NAME: Common: Timothy Dwight School Historic: Same
2. TOWN/CITY: New Haven VILLAGE: ----- COUNTY: New Haven
3. STREET & NUMBER (and/or location): Edgewood Avenue between Day and Dwight Streets
4. OWNER(S): City of New Haven PUBLIC PRIVATE
5. USE: Present: Education Historic: Same
6. ACCESSIBILITY TO PUBLIC: Exterior visible from public road: yes no
Interior accessible: yes, explain school no

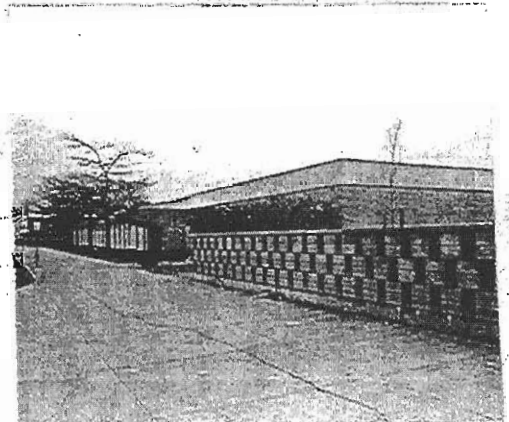
view: Northwest corner

This single storey school building forms a square around an interior courtyard with classrooms along the outer wall. The building's only windows face the courtyard, not visible from inside the classrooms. The facade consists of a beige brick base with upright rectangular panels alternating on 2 planes, one 6 inches recessed. These panels are faced in crushed white stone. A wide horizontal band of light beige concrete unifies the facade above. The 2 entrances occur near the front facade's ends and have concrete entry porches.

An addition to the building's southeast corner does have window bays.
