HISTORIC RESOURCES INVENTORY
BUILDING AND STRUCTURES
HIST-6 NEW 5 77

1. BUILDING NAME (Common) Crown St. Parking Garage		(Historic)	
2. TOWN/CITY New Haven		VILLAGE	COUNTY New Haven
3. STREET AND NUMBER (and/or location) Crown St. (corner of College St.)			
4. OWNER(S) New Haven Parking Authority <input checked="" type="checkbox"/> Public <input type="checkbox"/> Private			
5. USE (Present) Parking Garage (Historic)			
6. ACCESSIBILITY TO PUBLIC:	EXTERIOR VISIBLE FROM PUBLIC ROAD <input checked="" type="checkbox"/> Yes <input type="checkbox"/> No	INTERIOR ACCESSIBLE <input checked="" type="checkbox"/> Yes <input type="checkbox"/> No	IF YES, EXPLAIN During business hours

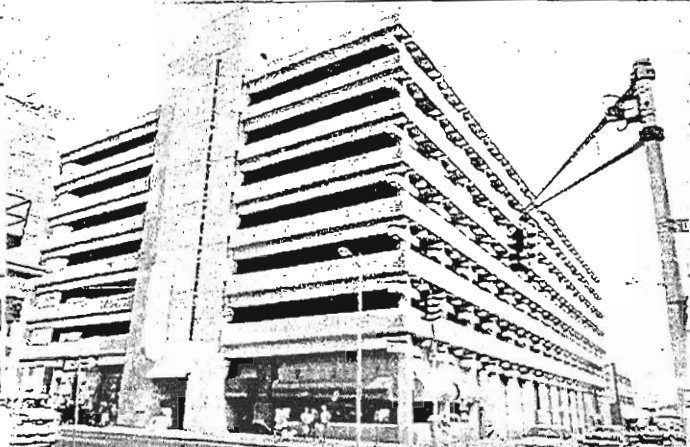
Building: 8-level parking garage in re-inforced concrete with utility/service towers and ramps. Building has complex structural system of pre-cast "T" shaped posts arranged in a grid-like fashion. These support re-inforced concrete beams which in turn, support the (poured) concrete floor. Sides have cast-concrete panels. The stair towers (which also hold elevators and utilities) are poured and reinforced concrete with textured surfaces. The ground floor (southwest corner) has an enclosed commercial space which fronts on the street. This has concrete block walls, horizontal window bands (with giant, cylindrical marquées overhead) and entries (on south and west sides). This commercial space was added in 1973.

South (Crown St, side)
