HISTORIC RESOURCES INVENTORY
BUILDING AND STRUCTURES

1. BUILDING NAME (Common)		(Historic)	
Same		New Haven Jewish Home for the Aged	
2. TOWN/CITY		VILLAGE	COUNTY
New Haven			New Haven
3. STREET AND NUMBER (and/or location)			
169 Davenport Ave.			
4. OWNER(S)			
New Haven Jewish Home for the Aged <input type="checkbox"/> Public <input checked="" type="checkbox"/> Private			
5. USE (Present)		(Historic)	
Residential/Medical		Same	
6. ACCESSIBILITY TO PUBLIC: EXTERIOR VISIBLE FROM PUBLIC ROAD INTERIOR ACCESSIBLE IF YES, EXPLAIN			
<input checked="" type="checkbox"/> Yes <input type="checkbox"/> No		<input checked="" type="checkbox"/> Yes <input type="checkbox"/> No By request

For Buildings and Structures New Haven Jewish Home
Davenport Ave.

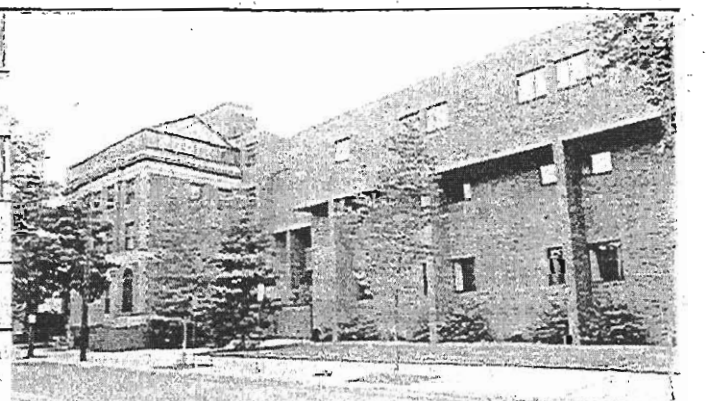
VIEW: South (front) NEGATIVE ON FILE: NHPT, CHC Sheet #78

Building: Complex consists of original building (4-story masonry and steel construction), 1950 rear wing (4-story, masonry and steel construction), and 1975 (east) side wing (3-story masonry and steel construction). The original building is 5 bays wide and has a flat roof. A glass and metal solarium was added to the roof in 1934. A mutually cornice crowns the mass and has a wide frieze, all in cast stone. Vertical quoin quoins rise from the basement to the cornice and are also constructed of cast-stone. At the center of the front facade is a shallow pavilion, 3 bays wide. Fenestration in the building is symmetrical with rectilinear windows in 2nd and 3rd stories and tall arched bays on 1st. floor. Arched bays have cast-stone keystones and impost blocks. A wide frieze in cast-stone divides 1st from 2nd stories. The entry is center and formal with a small projecting entry porch with recessed doors in an arched opening. Flanking the entry

engaged columns resting on a raised stoop. Flanking the entry porch are single bays on each side with pilasters. The whole is sheathed in rusticated cast-stone masonry. A wide entablature unites entry porch and center pavilion. The west side continues with same detail as front facade, including arched and rectilinear bays divided horizontally by cast-stone friezes.
