**HISTORIC RESOURCES INVENTORY**  
**BUILDING AND STRUCTURES**  
HIST-6 INEW 5 77

STATE OF CONNECTICUT  
**CONNECTICUT HISTORICAL COMMISSION**  
 59 SOUTH PROSPECT STREET, HARTFORD, CONNECTICUT 06106  
 (203) 566-3005

1. BUILDING NAME (Common) Gold Building		(Historic)	
2. TOWN/CITY New Haven		VILLAGE	COUNTY New Haven
3. STREET AND NUMBER (and or location) 234 Church St.			
4. OWNER(S) MGIC Financial St.		<input type="checkbox"/> Public <input checked="" type="checkbox"/> Private	
5. USE (Present) Commercial		(Historic) Same	
6. ACCESSIBILITY TO PUBLIC:	EXTERIOR VISIBLE FROM PUBLIC ROAD	INTERIOR ACCESSIBLE	IF YES, EXPLAIN
<input checked="" type="checkbox"/> Yes <input type="checkbox"/> No	<input checked="" type="checkbox"/> Yes <input type="checkbox"/> No	<input checked="" type="checkbox"/> Yes <input type="checkbox"/> No	DBH

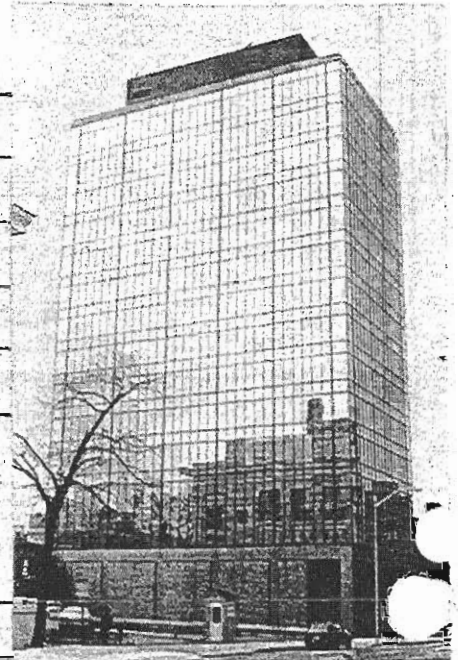
PHOTO

Building: 14 story fireproof office building on a small corner site. Building is steel frame construction. The exterior is sheathed in a reflective glass curtain wall. Metal frames in the curtain wall create a delicate grid of horizontal and vertical members. The lobby or ground level is recessed from the street and has glass walls. The piers are sheathed in cut-stone at this level.

PHOTOGRAPHER	Alan Rutberg	DATE	Oct. 1981
VIEW	South (side) East (front)	NEGATIVE ON FILE	NHPT, CHC Sheet #57
