HISTORIC RESOURCES INVENTORY  
BUILDING AND STRUCTURES  
HIST-6 NEW 5 77

1. BUILDING NAME (Common) (Historic)  
The Connecticut State Medical Society | Same

3. STREET AND NUMBER (and/or location)  
160 St. Ronan Street (at Edwards Street)

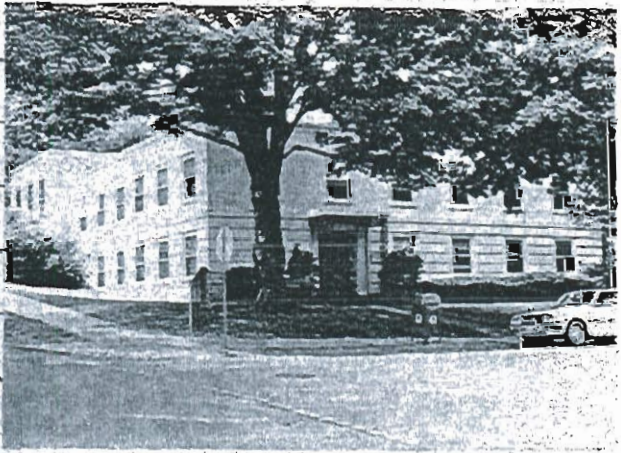
VIEW Southeast NEGATIVE ON FILE CHC;NHPT;Sheet#70

<input type="checkbox"/> Excellent	<input checked="" type="checkbox"/> Good	<input type="checkbox"/> Fair	<input type="checkbox"/> Deteriorated	<input type="checkbox"/> Excellent	<input checked="" type="checkbox"/> Good	<input type="checkbox"/> Fair	<input type="checkbox"/> Deteriorated
------------------------------------	--	-------------------------------	---------------------------------------	------------------------------------	--	-------------------------------	---------------------------------------

The massing of the building consists of 3 simple, rectangular wings, the rear ones set uphill and therefore slightly higher than the front wing. Classical details include schematic modillion cornice (in brick) which functions as a parapet, and 1st story treated as a basement with raised rectangular bands of brickwork. Main entrance, off-center on facade, is framed with stylized, fluted pilasters and simplified entablature. Flat-roof entrance porch is supported and trimmed with lattice ironwork strips. Lattice porch feature is repeated in another porch at rear of building, which also carries the name of the institution. Main entrance double, paneled door is similar to those of many Colonial Revival houses throughout the Prospect Hill area.
