HISTORIC RESOURCES INVENTORY FORM

1. BUILDING NAME: Common: Trade Union Plaza Historic: Same
2. TOWN/CITY: New Haven VILLAGE: ----- COUNTY: New Haven
3. STREET & NUMBER (and/or location): Between 450-512 George Street
4. OWNER(S): City of New Haven X PUBLIC PRIVATE
5. USE: Present: Multi-Family Historic: Same
6. ACCESSIBILITY TO PUBLIC: Exterior visible from public road: X yes no
Interior accessible: yes, explain X no

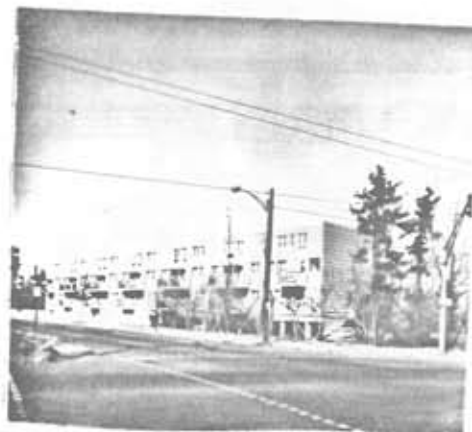
PHOTOGRAPH

This complex of 9 rectangular buildings is built of concrete block with a shingle-like textured surface. The facades have small casement windows and are broken by scattered concrete porches 1 bay wide. Open car ports exist below grade. The complex contains 77 units: 45 are 1st storey flats and 42 are duplexes.

photographer: Thomas Hahndate: Fall, 1979 view: North elevationnegative on file: CHC; CTHP
